ONTARIO NORTHLAND RAILWAY
NORTH BAY YARD
CONSOLIDATION OF REPAIR FACILITIES

**ONTARIO NORTHLAND RAILWAY
NORTH BAY YARD
CONSOLIDATION OF REPAIR FACILITIES**

DESIGNATED SUBSTANCES SURVEY REPORT
ONTARIO NORTHLAND REMANUFACTURING AND REPAIR CENTRE
916 MCINTYRE STREET EAST
NORTH BAY, ONTARIO

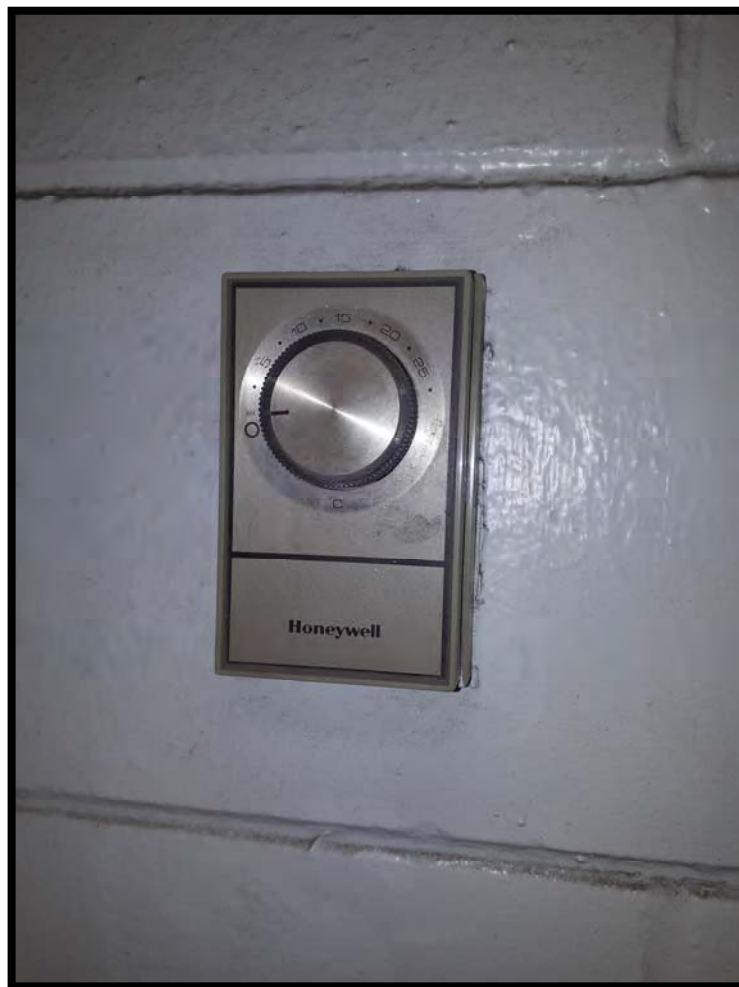
Photo # 65

*Wall mounted "Honeywell" Thermostatic Control Switch – Mercury Containing.
Located within the "Old" Paint & Grit Shop – Room 10.
Typical of other Thermostats' found throughout all buildings*

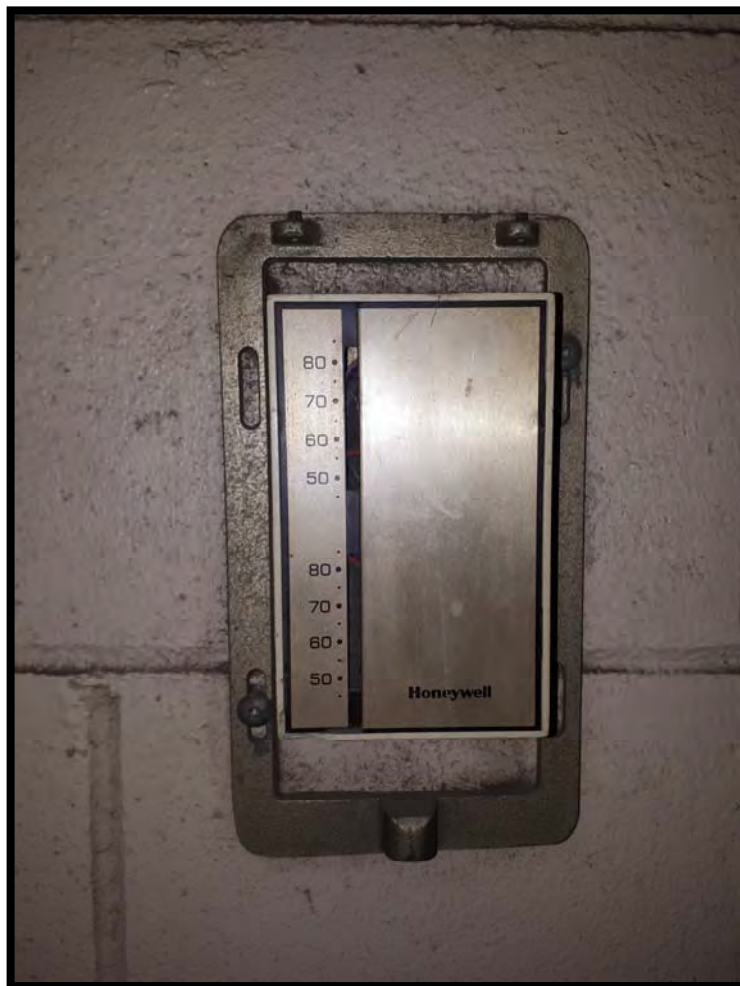
Photo # 66

*Wall mounted "Honeywell" Thermostatic Control Switch – Mercury Containing.
Located within the Diesel Shop – Room D.
Typical of other Thermostats' found throughout all buildings.*
