ONTARIO NORTHLAND RAILWAY
NORTH BAY YARD
CONSOLIDATION OF REPAIR FACILITIES

**ONTARIO NORTHLAND RAILWAY
NORTH BAY YARD
CONSOLIDATION OF REPAIR FACILITIES**

DESIGNATED SUBSTANCES SURVEY REPORT
ONTARIO NORTHLAND REMANUFACTURING AND REPAIR CENTRE
916 MCINTYRE STREET EAST
NORTH BAY, ONTARIO

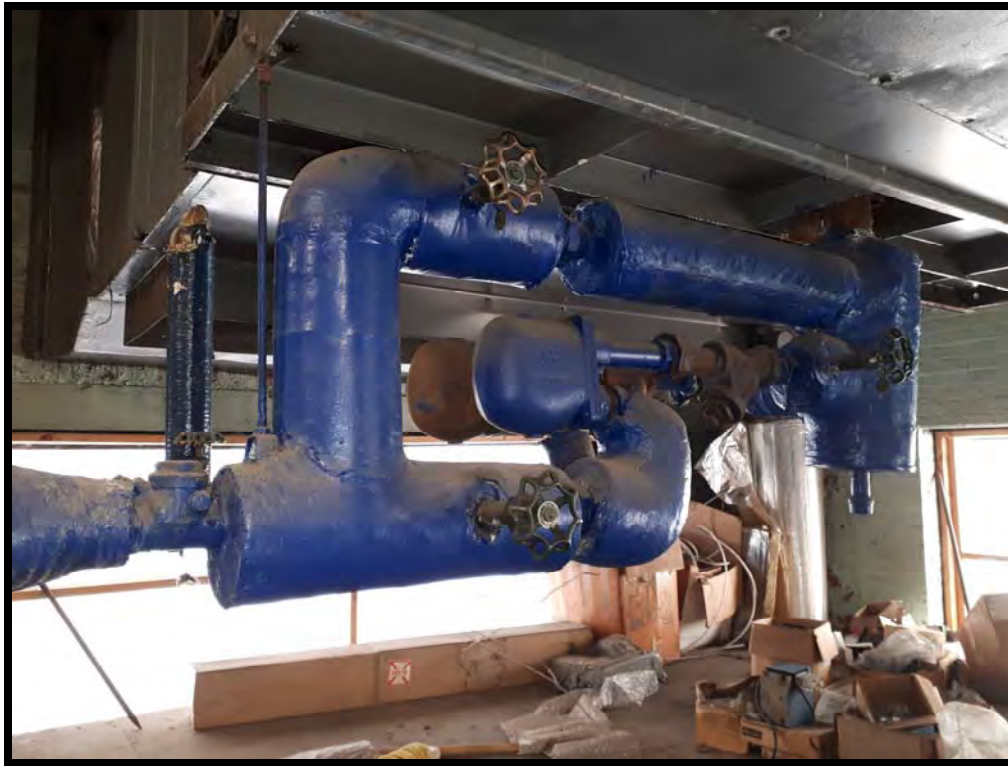
PHOTO # 7

*Sample # ONR – 2 : Asbestos-containing Pipe Insulation
on Condensate lines in Power House. (80% amosite asbestos)*

Should future activities (demolition/renovation) occur within the buildings noted above which would disturb the asbestos-containing noted in this report, Thomas Contracting recommends that the affected material(s) be removed prior to these activities. This work must be carried out as outlined in R.R.O 2005, Reg. 278, Regulation respecting Asbestos on Construction Projects and in Building and Repair Operations.

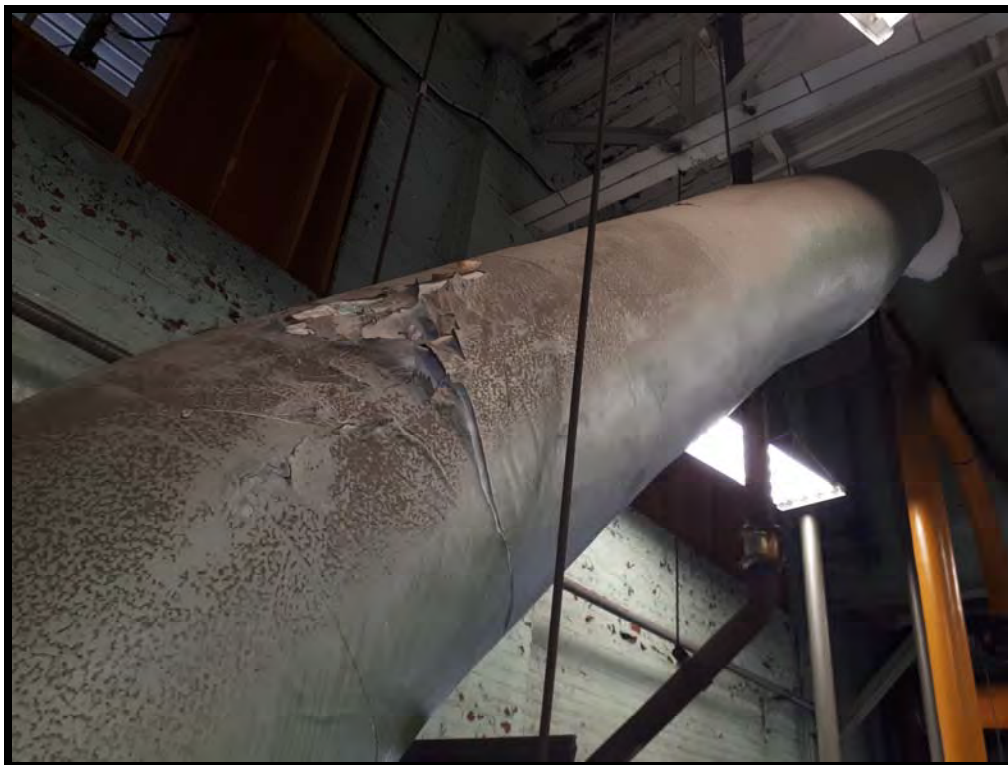
PHOTO # 8

*Sample # ONR 3 : Asbestos-containing Exhaust / Breeching Insulation
on Boilers in Power House. (50% chrysotile asbestos)*

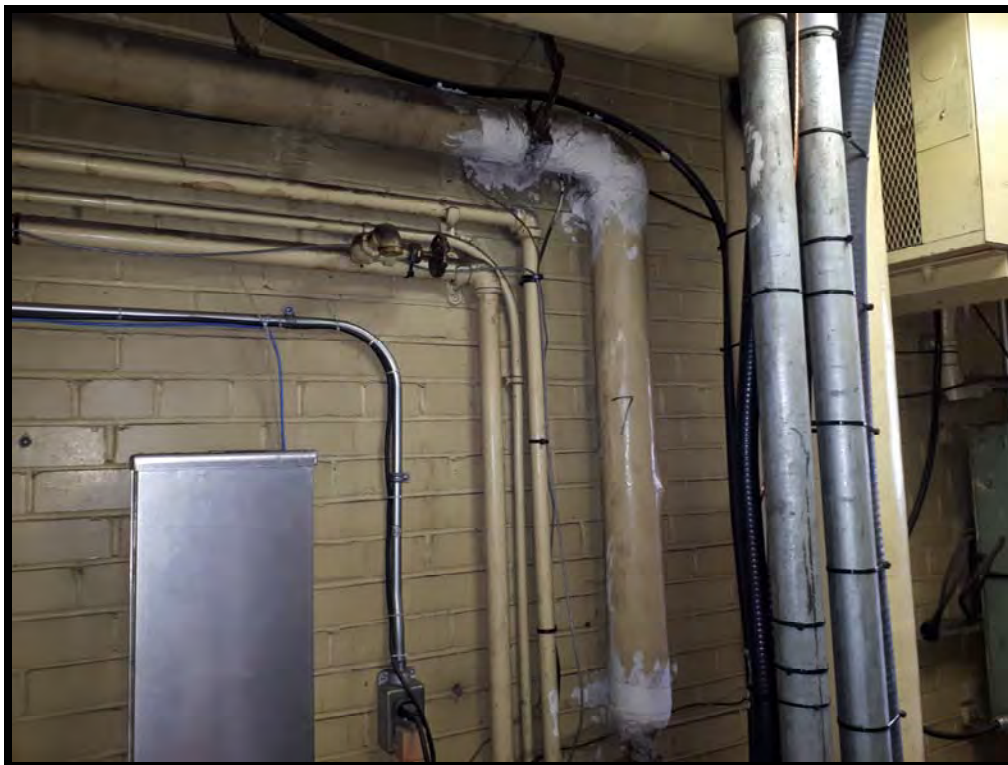
PHOTO # 10

Sample # ONR – 7 : Asbestos-containing Pipe Insulation (anti-sweat)
on Cold Water Lines in Wheel Shop – Electrical Room. (1% chrysotile asbestos)

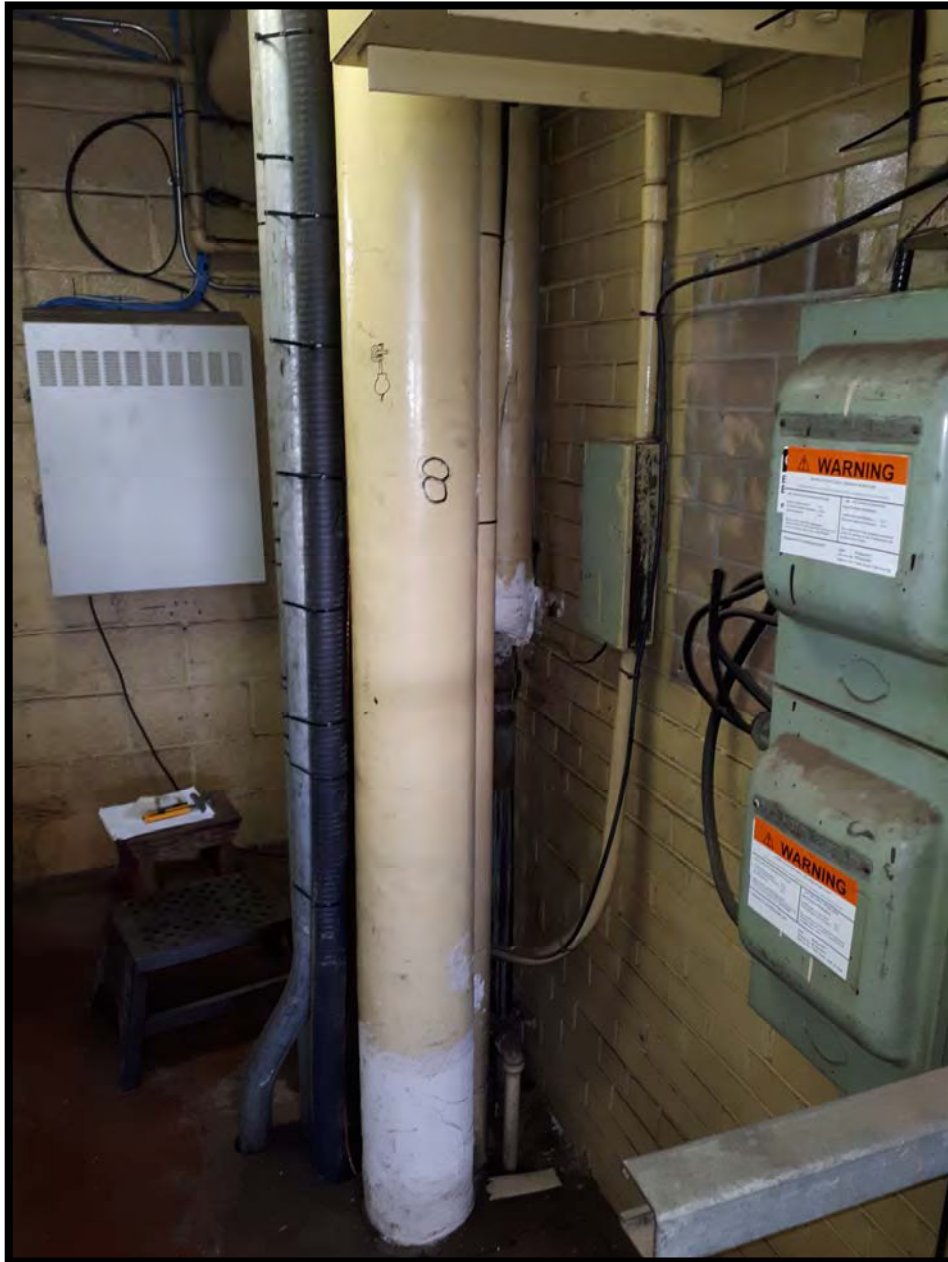
PHOTO # 11

*Sample # ONR – 8 : Asbestos-containing Pipe Insulation on High Pressure Steam lines
in Wheel Shop – Electrical Room. (90% chrysotile asbestos)*

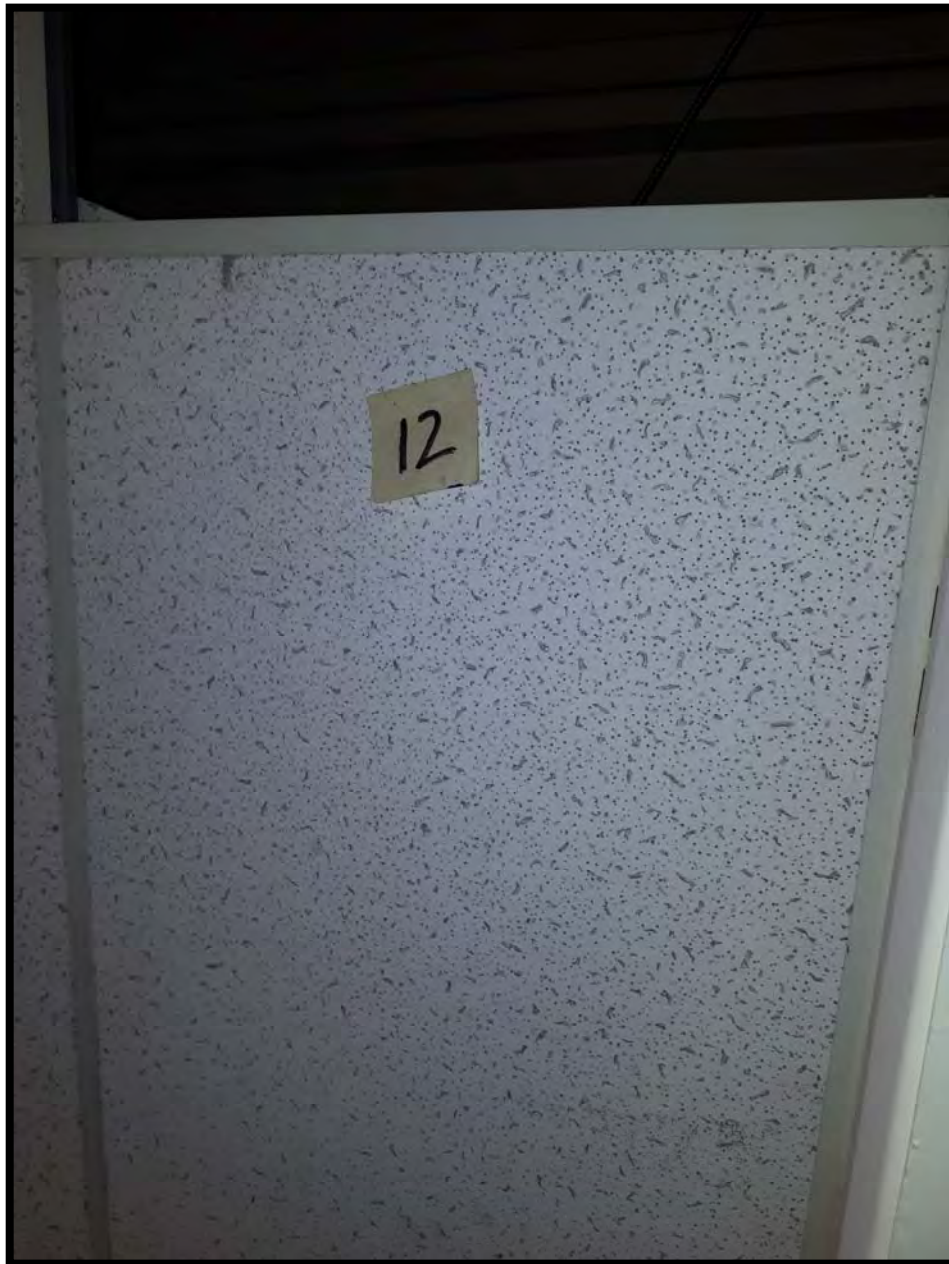
PHOTO # 12

Sample # ONR – 12 : Non-asbestos 2' x 4' Drop Ceiling Tiles in Wheel Shop – Room # 2.

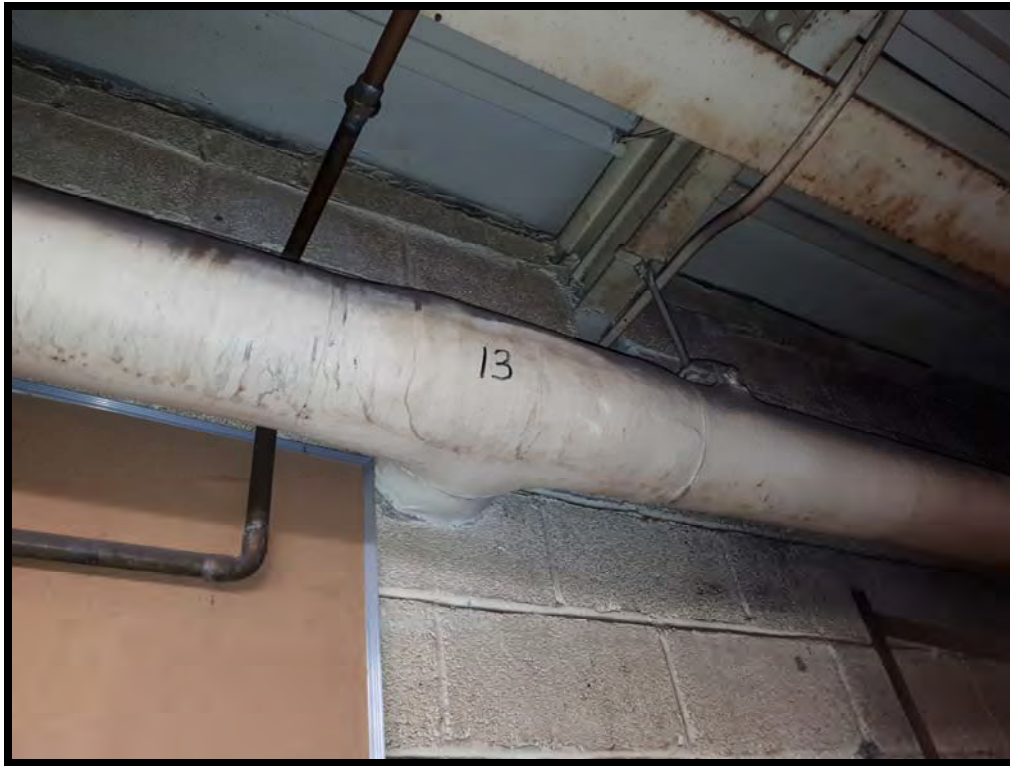
PHOTO # 13

*Sample # ONR – 13 : Asbestos-containing Elbow / Clean-out Insulation
on Rain Leader lines in Wheel Shop – Room # 3. (80% chrysotile asbestos)*

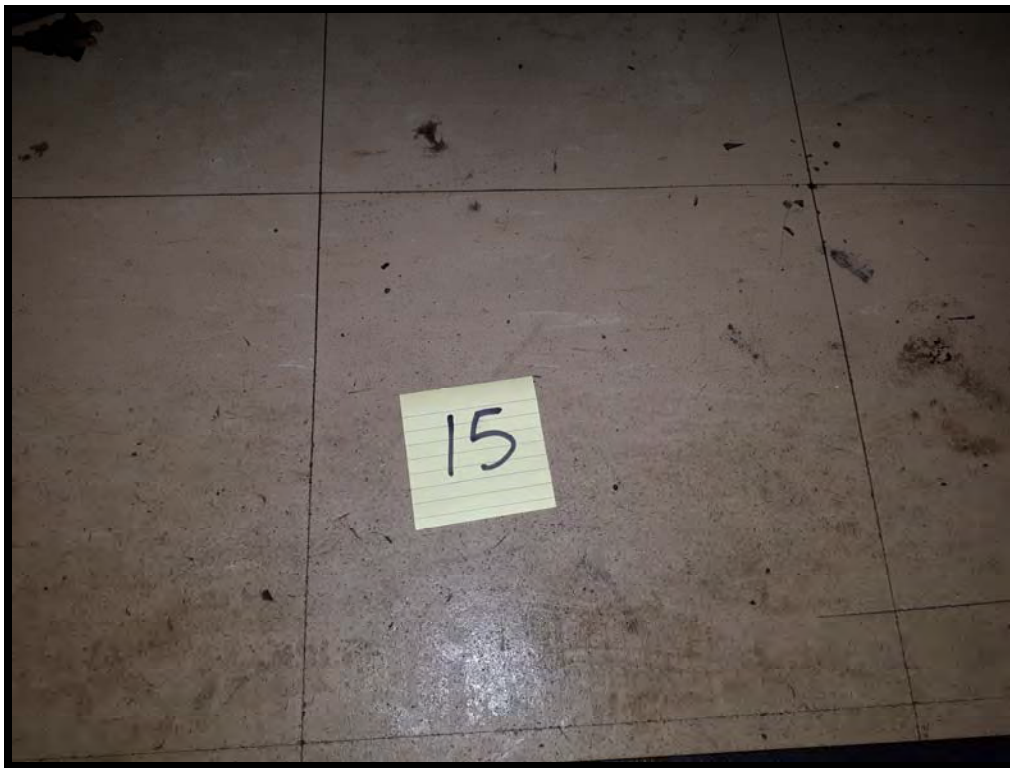
PHOTO # 14

Sample # ONR – 15 : Non-asbestos 12" x 12" vinyl floor tile in Wheel Shop – Room # 5.

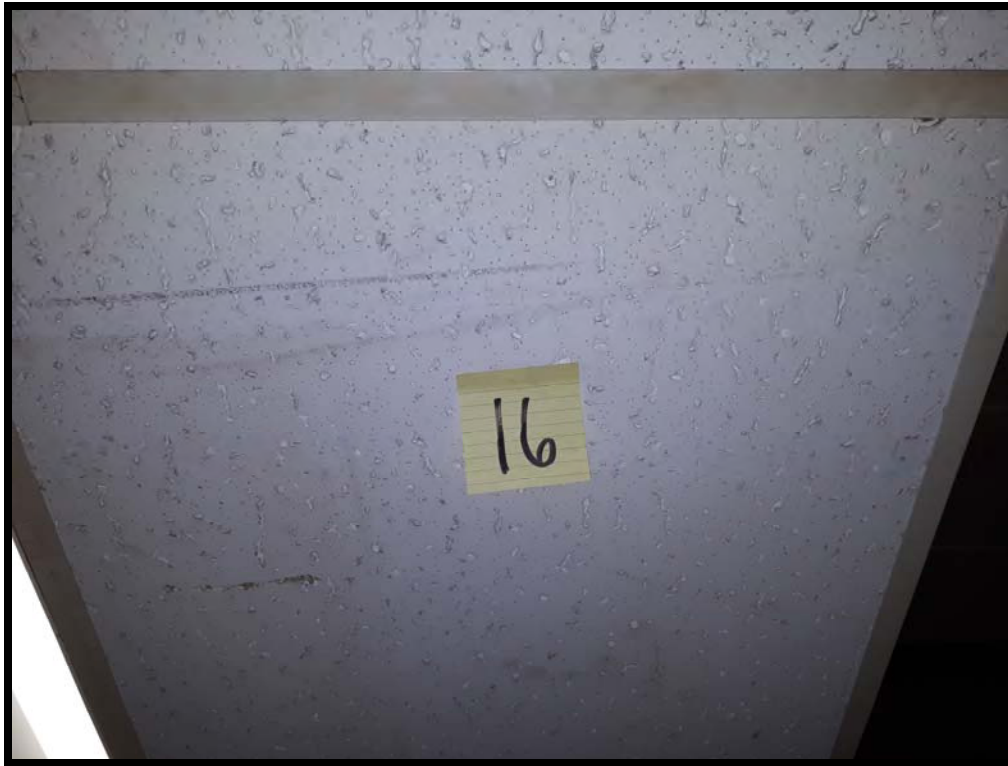
PHOTO # 15

Sample # ONR – 16 : Non-asbestos 2' x 4' Drop Ceiling Tiles in Wheel Shop – Room # 5..

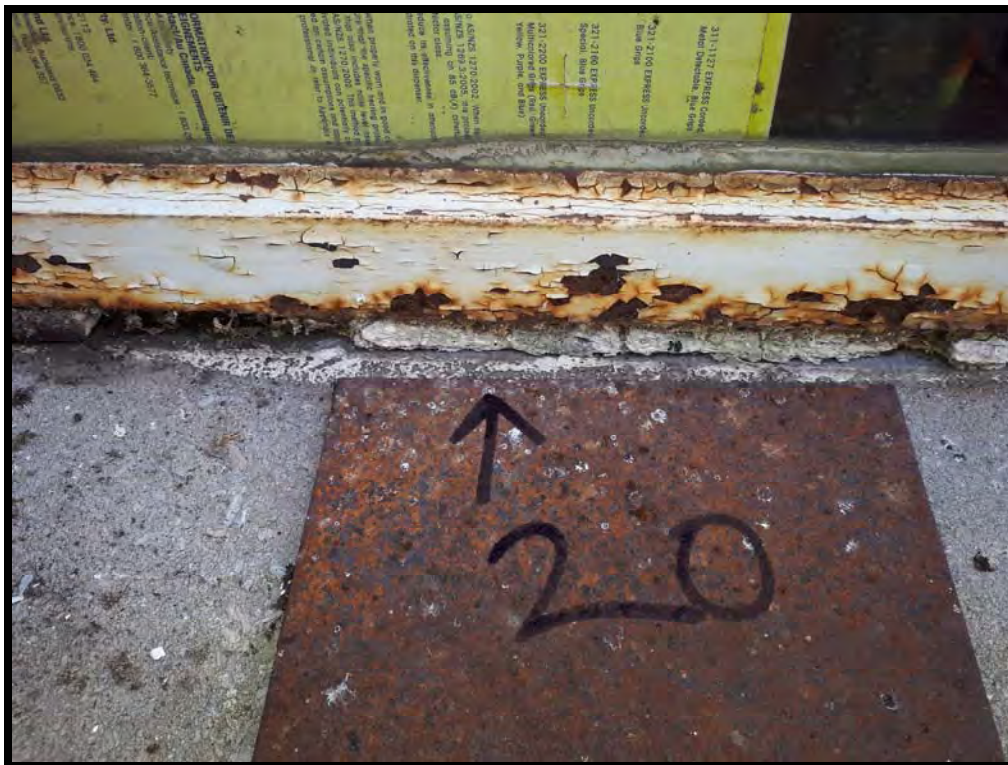
PHOTO # 16

Sample # ONR – 20 : Asbestos-containing Window / Door Caulking
on Exterior of Wheel Shop. (20 % Chrysotile asbestos)

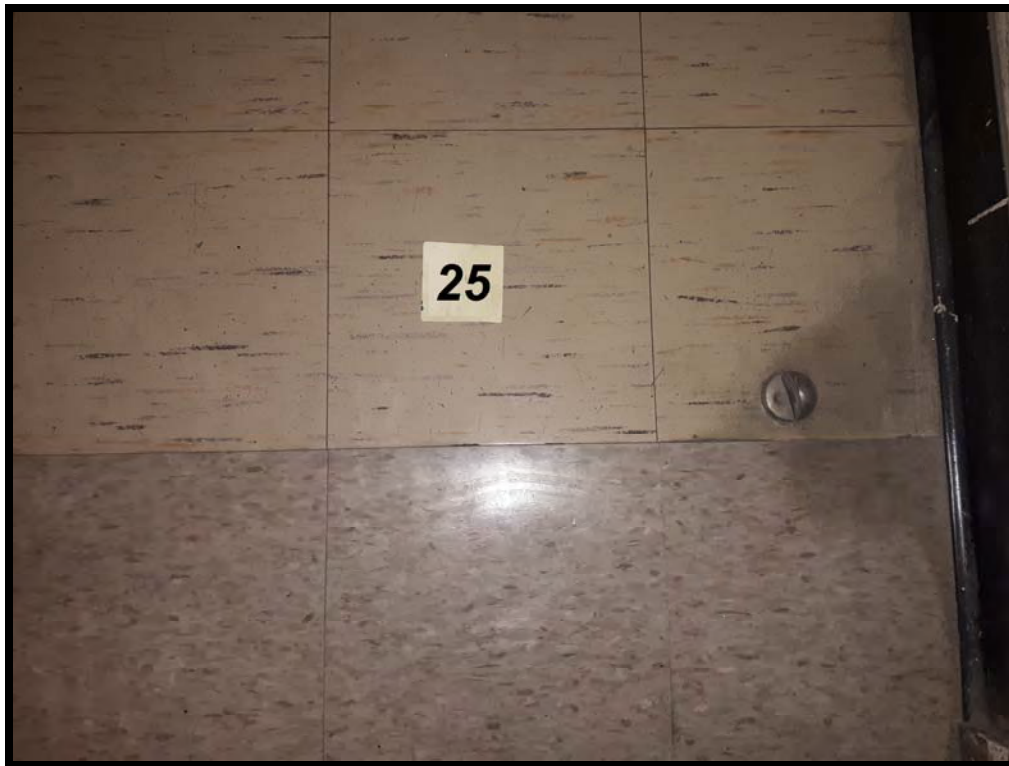
PHOTO # 17

Sample # ONR – 25 : Asbestos-containing 12" x 12" Vinyl Floor Tile in
Paint Shop – Room # 5. (1% chrysotile asbestos)

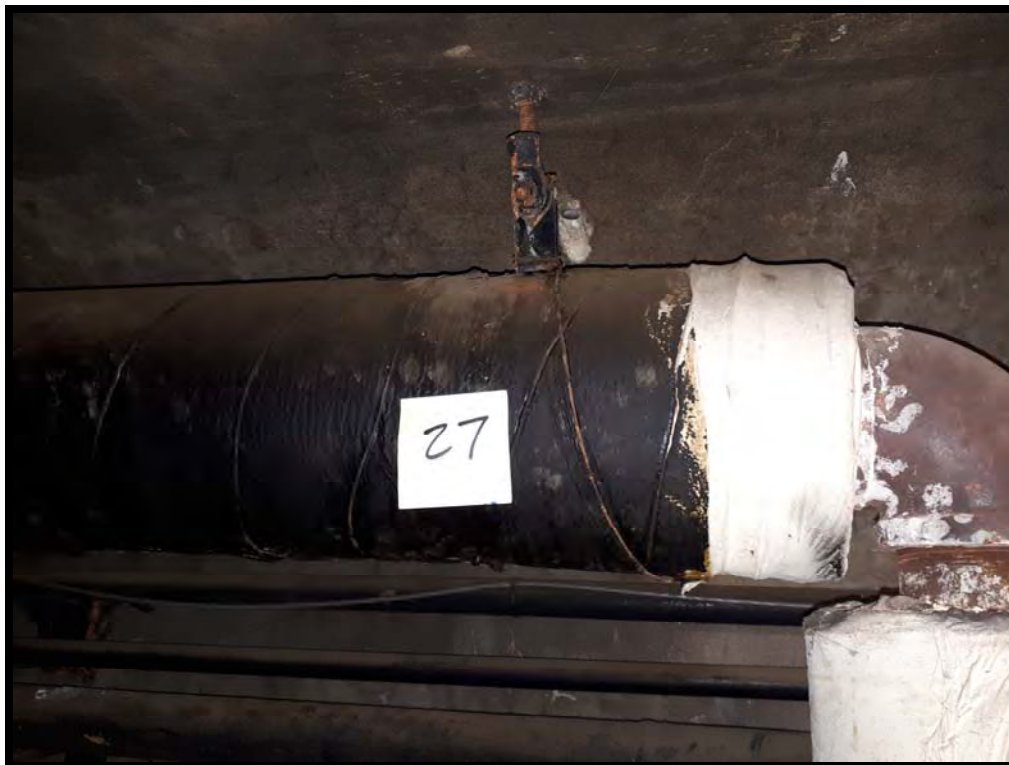
PHOTO # 18

Sample # ONR – 27 : Asbestos-containing Pipe Insulation (white mag-block)
on Steam lines in Diesel Shop - Tunnel. (80% chrysotile asbestos)

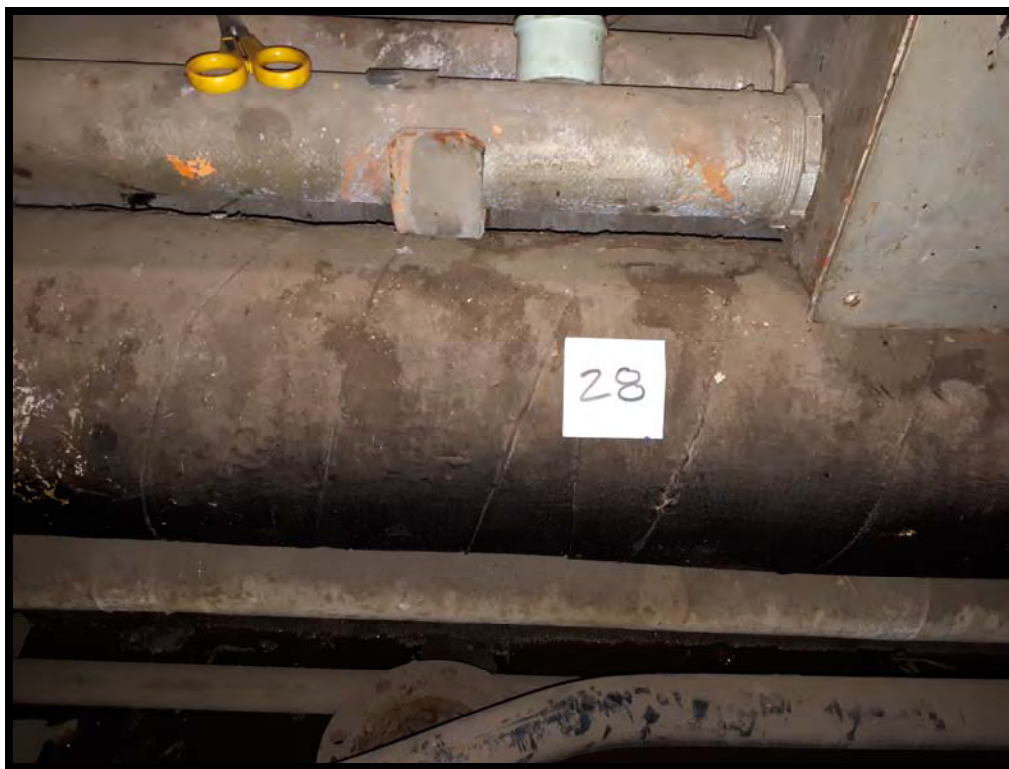
PHOTO # 19

*Sample # ONR - 28 : Asbestos-containing Tar Paper Wrap
on Steam lines in Diesel Shop - Tunnel. (10% chrysotile asbestos)*

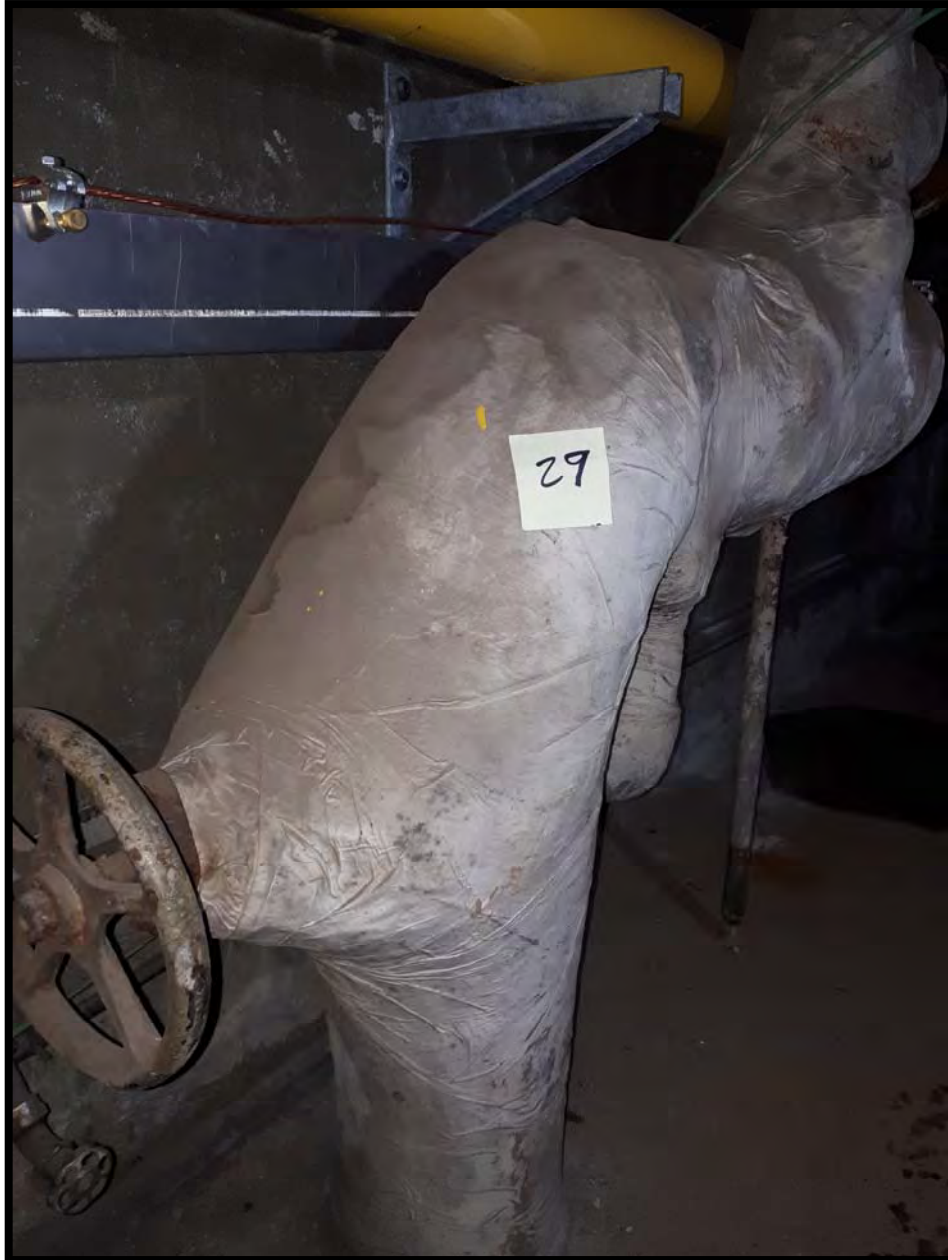
PHOTO # 20

Sample # ONR – 29 : Asbestos-containing Elbow / Fitting Insulation
on Cold water lines in Diesel Shop - Tunnel. (45% chrysotile and 45% amosite asbestos)

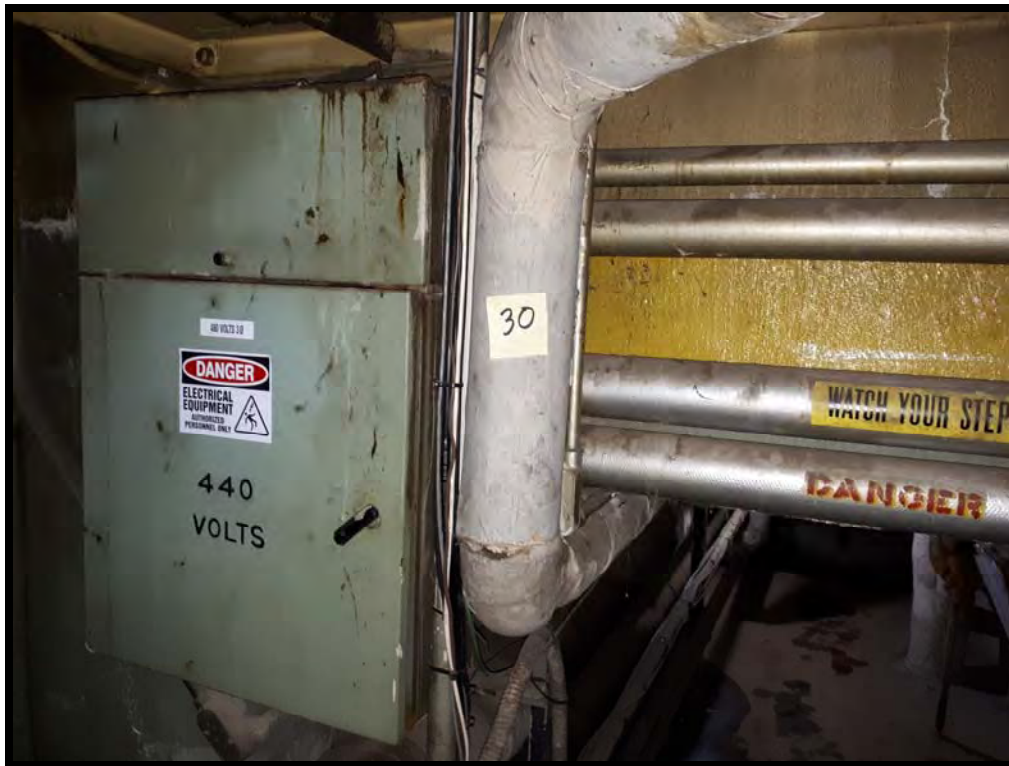
PHOTO # 21

Sample # ONR – 30 : Asbestos-containing Pipe Insulation (anti-sweat) on Cold water lines in Diesel Shop - Tunnel. (1% chrysotile asbestos)

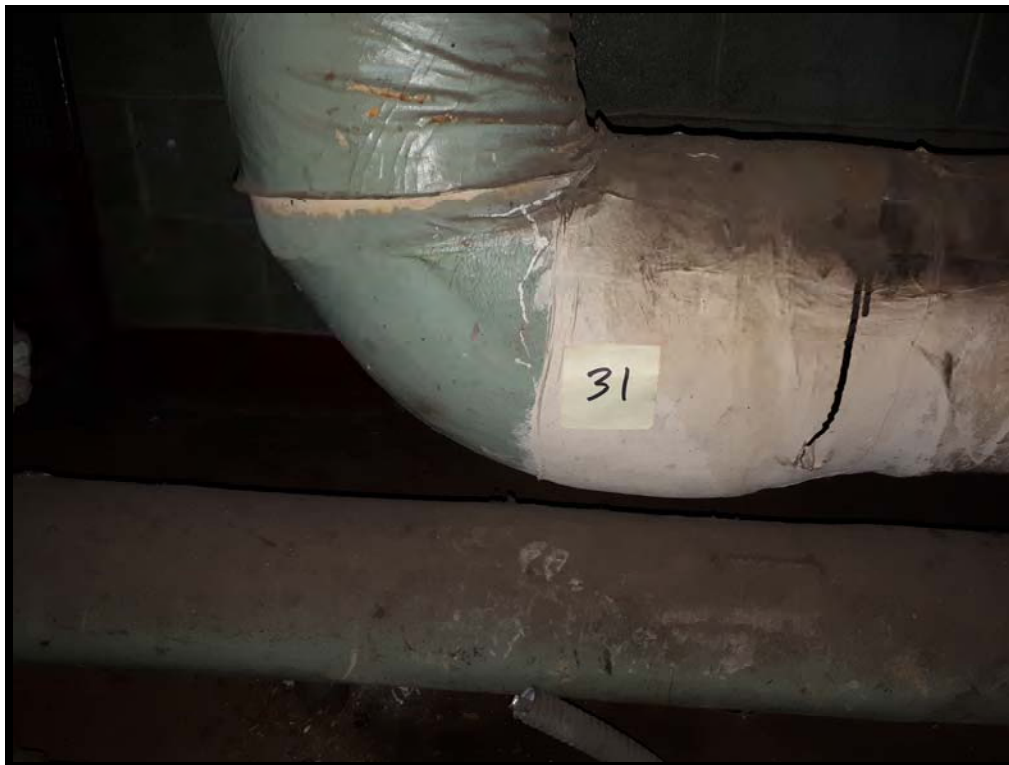
PHOTO # 22

Sample # ONR – 31 : Asbestos-containing Elbow / Fitting Insulation on Steam lines in Diesel Shop – Tunnel (10% chrysotile and 80% amosite asbestos).

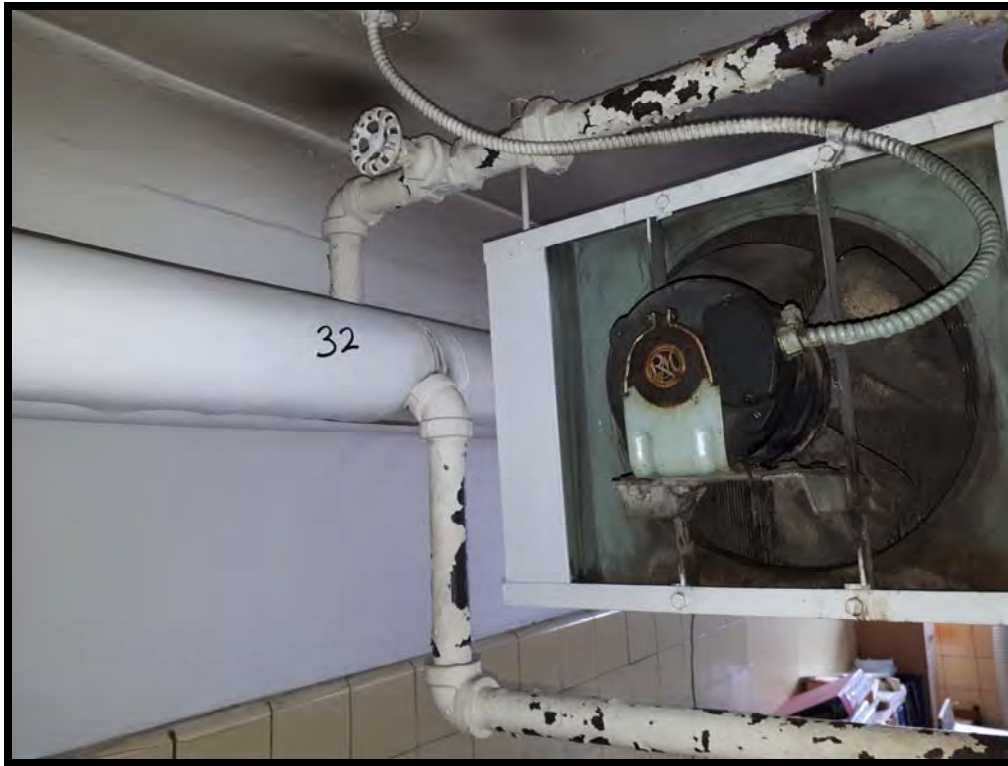
PHOTO # 23

Sample # ONR – 32 : Asbestos-containing Pipe Insulation (anti-sweat) on Heating lines in Diesel Shop - Room # 1. (60% chrysotile asbestos)

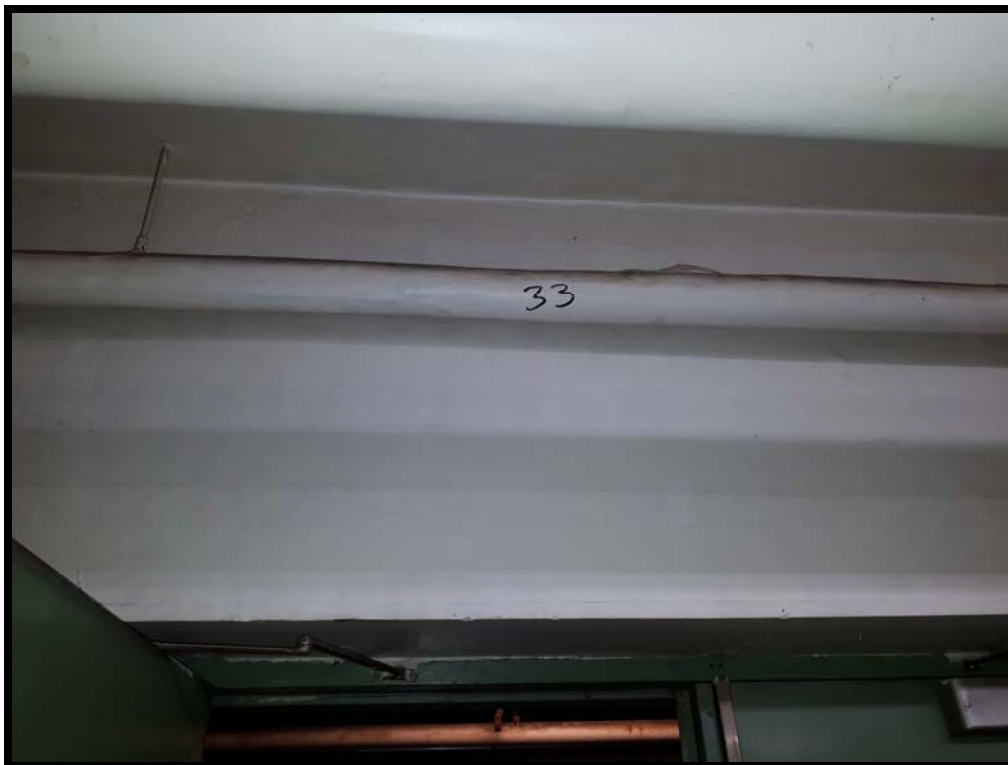
PHOTO # 24

ONR – 24a	-	"Old" Paint Shop Room 4	Drywall Joint Compound on walls	None Detected
ONR – 24b	-	"Old" Paint Shop Room 4	Drywall Joint Compound on walls	None Detected
ONR – 25	17	"Old" Paint Shop Room 5	12" x 12" Vinyl Floor Tile	1 % Chrysotile
ONR – 27	18	Diesel Shop Tunnel	Pipe Insulation on Steam lines (white mag-block)	80 % Chrysotile
ONR – 28	19	Diesel Shop Tunnel	Tar Paper Wrap on Steam lines	10 % Chrysotile
ONR – 29	20	Diesel Shop Tunnel	Elbow / Fitting Insulation on Cold water lines	45 % Chrysotile 45 % Amosite
ONR – 30	21	Diesel Shop Tunnel	Pipe Insulation (anti-sweat) on Cold water lines	1 % Chrysotile
ONR – 31	22	Diesel Shop Tunnel	Elbow / Fitting Insulation on Steam lines	10 % Chrysotile 80 % Amosite
ONR – 32	23	Diesel Shop Room # 1	Pipe Insulation (anti-sweat) on Heating lines	60 % Chrysotile
ONR – 33	24	Diesel Shop Room # 3	Pipe Insulation on Cold water lines (anti-sweat / tar paper)	7 % Chrysotile

Sample # ONR – 33 : Asbestos-containing Pipe Insulation (anti-sweat / tar paper) on Cold water lines in Diesel Shop - Room # 3. (7% chrysotile asbestos).

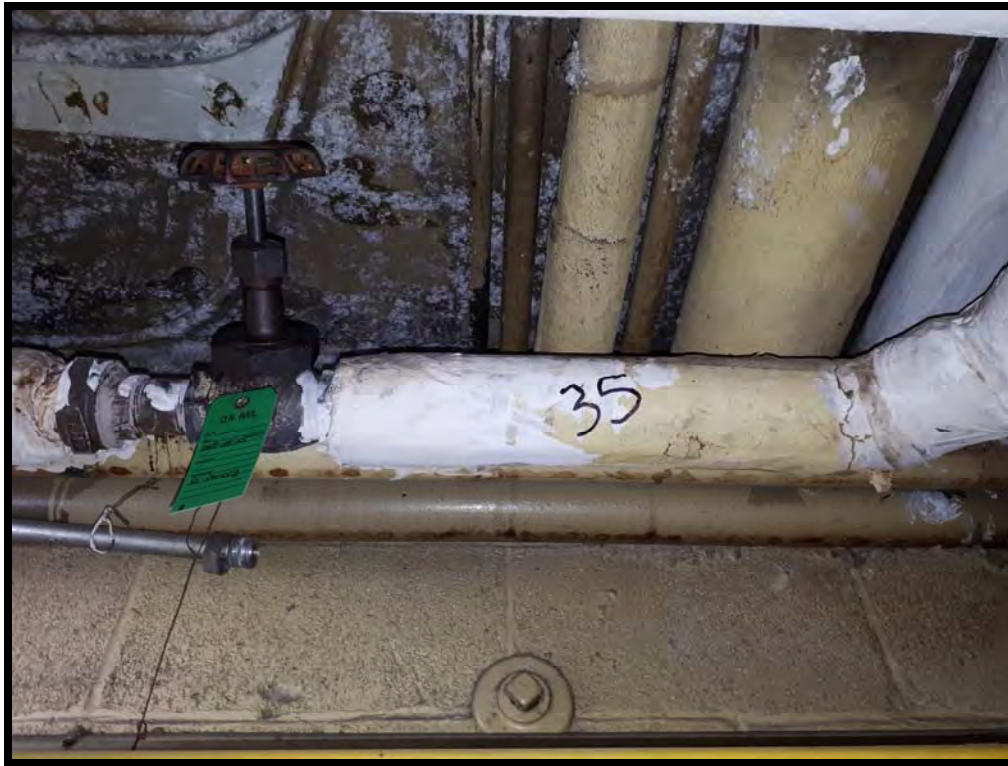
PHOTO # 25

Sample # ONR – 35 : Asbestos-containing Pipe Insulation (air-cell)
on Steam lines in Diesel Shop - Room # 6. (60% chrysotile asbestos)

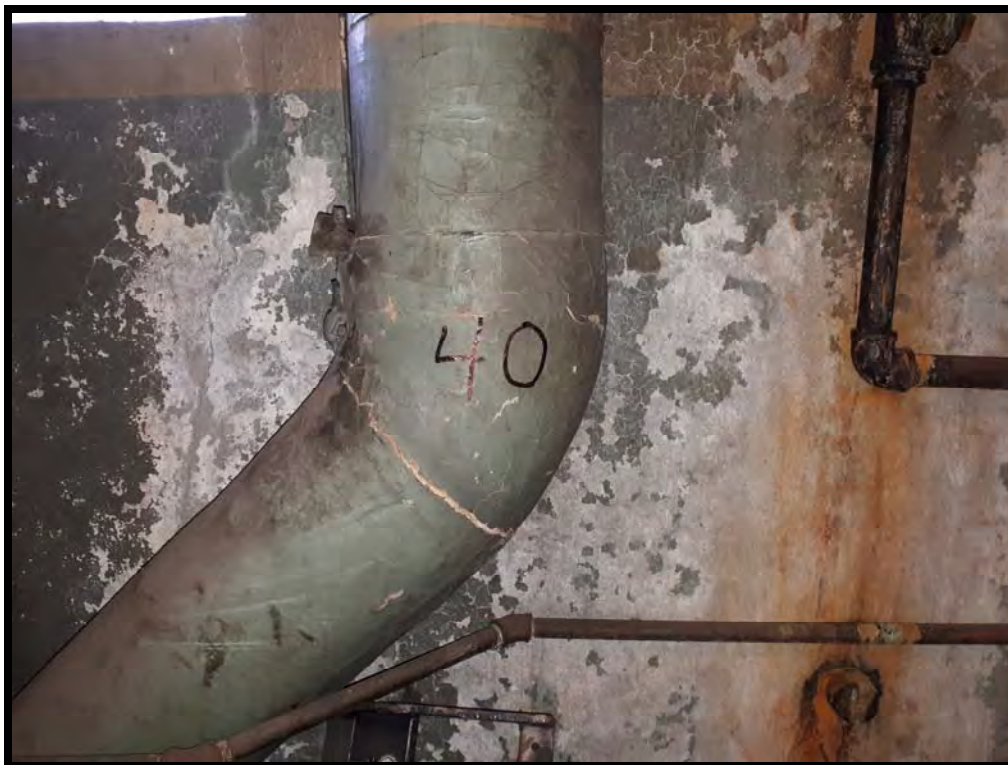
PHOTO # 26

Sample # ONR – 40 : Asbestos-containing Elbow / Fitting Insulation
on Cold water lines in Diesel Shop - Room # 4. (80% chrysotile asbestos)

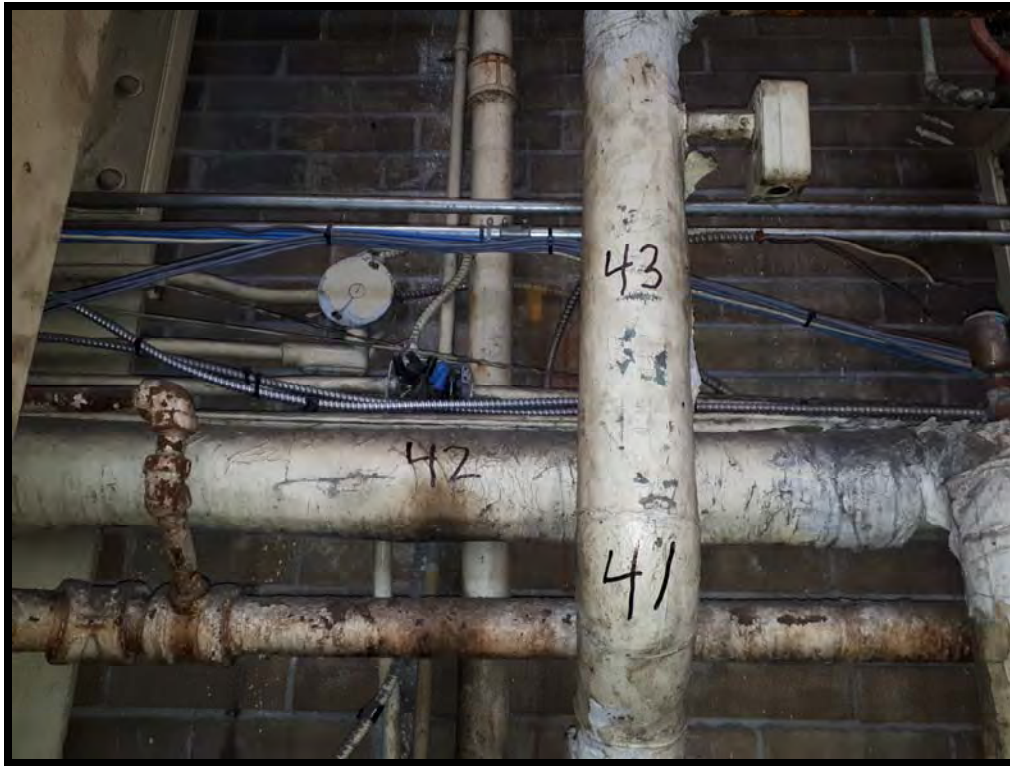
PHOTO # 27

Comments: This sample meets the definition of "asbestos containing material" according to Ontario Regulation 278/05.	
Client Sample: <u>ONR - 42</u>	Asbestos Detected? Yes	
LEX Sample: 13	Chrysotile: 80	Cellulose: 10
Layers Analyzed: Sample Homogenized	Amosite: None Detected	MMVF: None Detected
Colour: Yellow	Crocidolite: None Detected	Other Fibres: None Detected
Description: Pipe Insulation (anti-sweat) on Heating lines in Diesel Shop - East-side	Other Amphiboles: None Detected	Non Fibrous: 10
	Comments: This sample meets the definition of "asbestos containing material" according to Ontario Regulation 278/05.	
Client Sample: <u>ONR - 43</u>	Asbestos Detected? Yes	
LEX Sample: 14	Chrysotile: 50	Cellulose: 40
Layers Analyzed: Sample Homogenized	Amosite: None Detected	MMVF: None Detected
Colour: Beige	Crocidolite: None Detected	Other Fibres: None Detected
Description: Pipe Insulation (anti-sweat) on Heating lines in Diesel Shop - East-side	Other Amphiboles: None Detected	Non Fibrous: 10

Sample # ONR – 41, 42 and 43 : Asbestos-containing Elbow / Fitting and Pipewrap Insulation on Heating lines in Diesel Shop - East-side. (80% chrysotile asbestos)

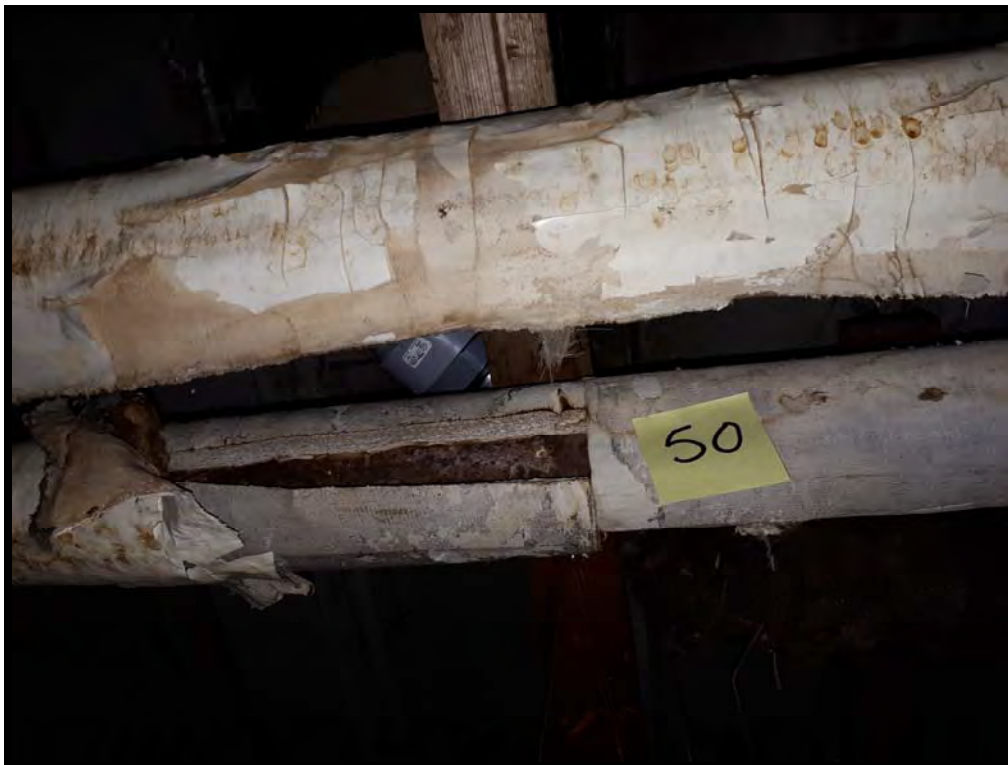
PHOTO # 32
Sample # ONR – 50 : Asbestos-containing Pipe Insulation (anti-sweat)
on Heating lines in Diesel Shop - Room # 17. (70% chrysotile asbestos)

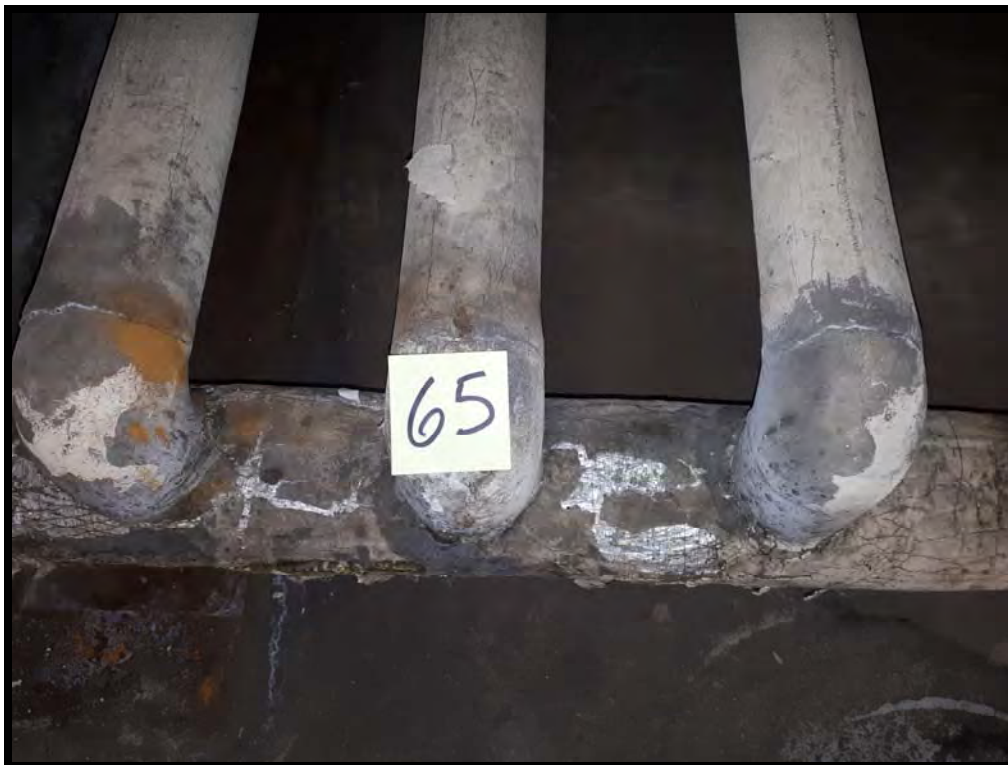
PHOTO # 40

Sample # ONR – 65 : Asbestos-containing Elbow / Fitting Insulation
on pipes in Car Shop - Room # 200. (60% chrysotile asbestos).

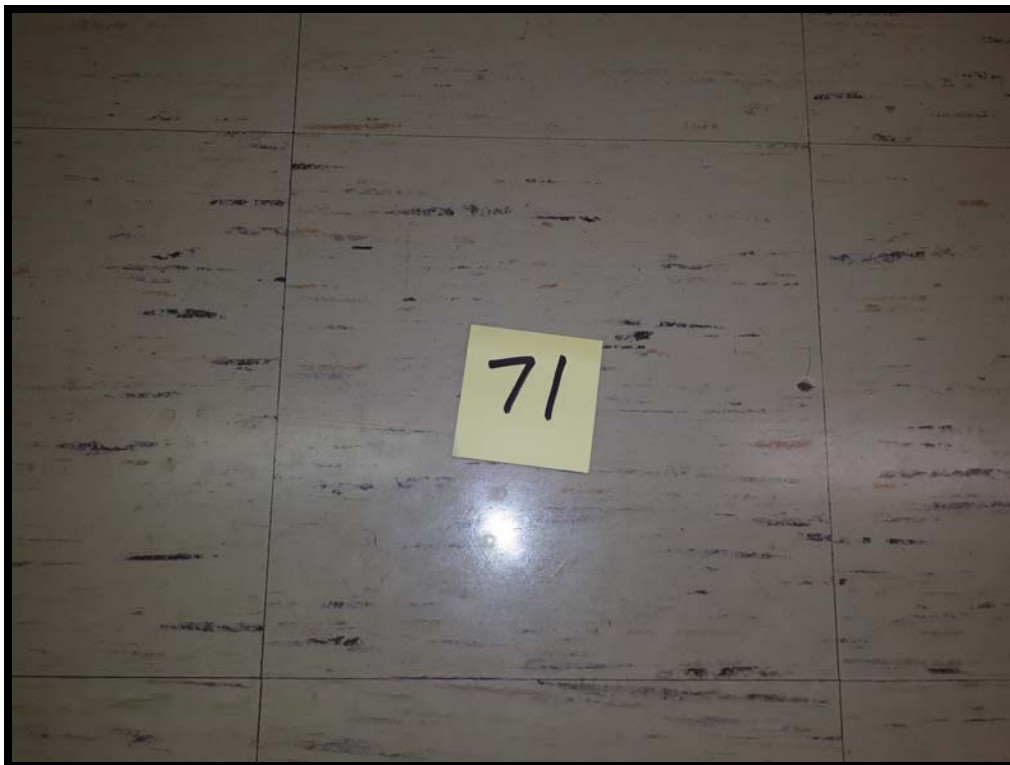
Comments: N/A	
Client Sample: <u>ONR-71</u>		Asbestos Detected? Yes	
LEX Sample: 09		Chrysotile: 25	Cellulose: None Detected
Layers Analyzed: Sample Homogenized		Amosite: None Detected	MMVF: None Detected
Colour: Beige		Crocidolite: None Detected	Other Fibres: None Detected
Description: 12"x12" Vinyl Floor Tile in Car Shop - Room # G	Other Amphiboles: None Detected	Non Fibrous: 75	
		Comments: This sample meets the definition of "asbestos containing material" according to Ontario Regulation 278/05.	
Client Sample: <u>ONR-72</u>		Asbestos Detected? Yes	
LEX Sample: 10		Chrysotile: 8	Cellulose: None Detected
Layers Analyzed: Sample Homogenized		Amosite: None Detected	MMVF: None Detected
Colour: Grey		Crocidolite: None Detected	Other Fibres: None Detected
Description: Caulking on exterior windows of Diesel Shop	Other Amphiboles: None Detected	Non Fibrous: 92	
		Comments: This sample meets the definition of "asbestos containing material" according to Ontario Regulation 278/05.

PHOTO # 42
Sample # ONR – 71 : Asbestos-containing 12" x 12" Vinyl Floor Tile
in Car Shop - Room # G (25% chrysotile asbestos)

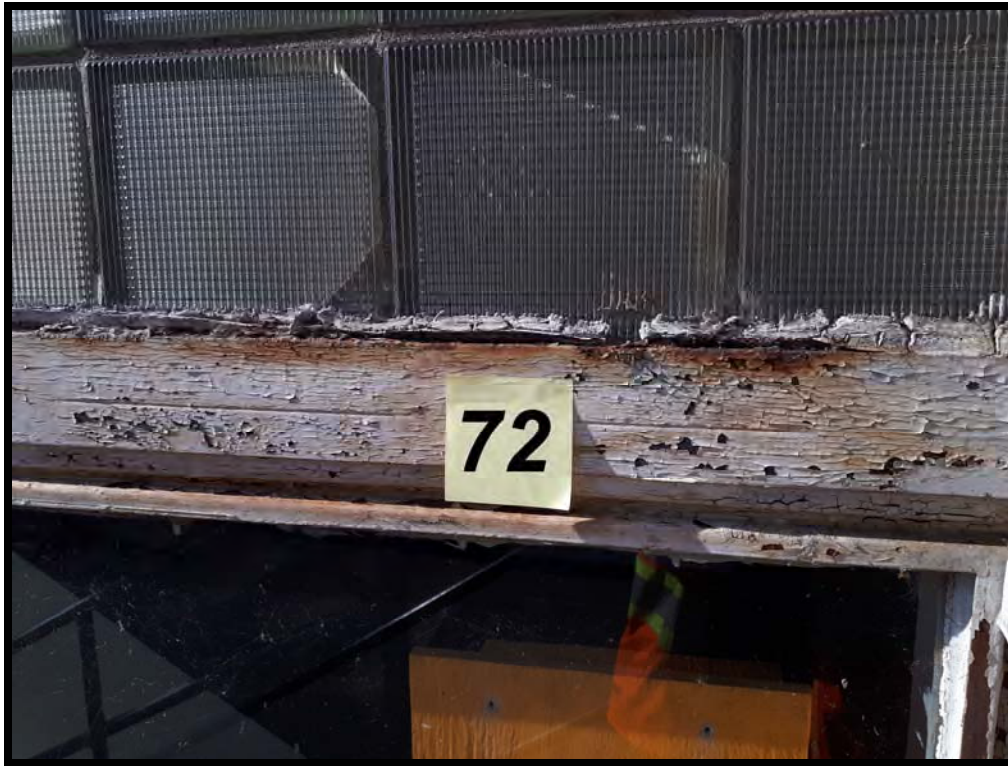
PHOTO # 43

Sample # ONR – 72 : Asbestos-containing Caulking
on exterior widows of Diesel Shop. (8% chrysotile asbestos)

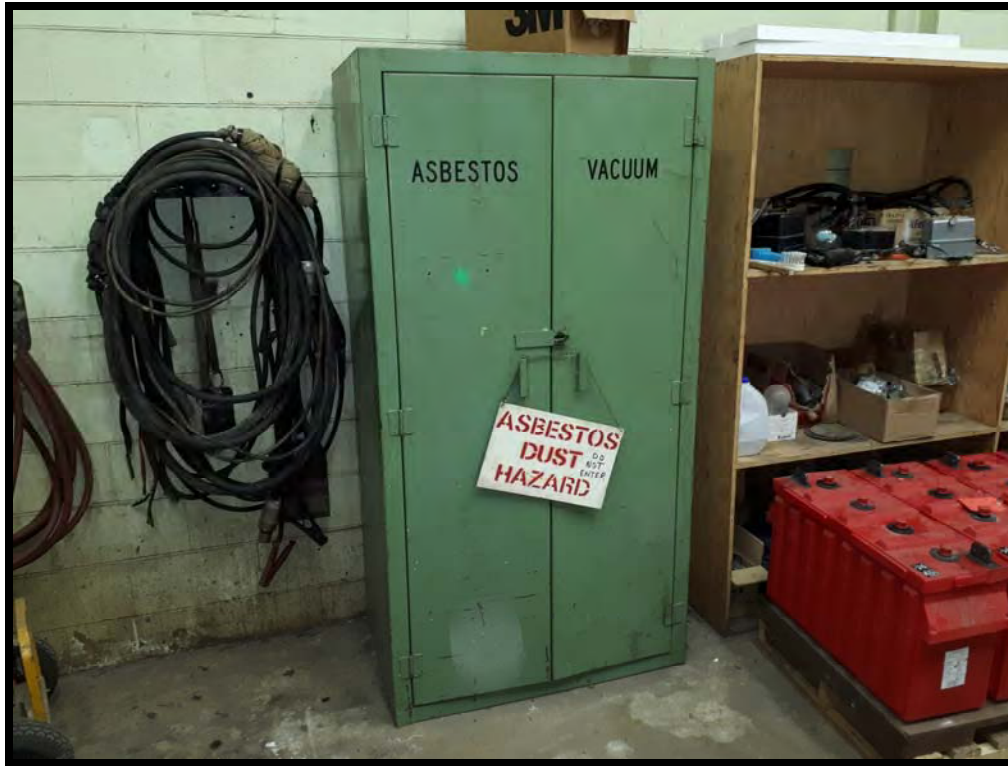
PHOTO # 43b
*Asbestos-containing materials within storage cabinet
in Car Shop – Room 117*
