ONTARIO NORTHLAND RAILWAY
NORTH BAY YARD
CONSOLIDATION OF REPAIR FACILITIES

**ONTARIO NORTHLAND RAILWAY
NORTH BAY YARD
CONSOLIDATION OF REPAIR FACILITIES**

DESIGNATED SUBSTANCES SURVEY REPORT
ONTARIO NORTHLAND REMANUFACTURING AND REPAIR CENTRE
916 MCINTYRE STREET EAST
NORTH BAY, ONTARIO

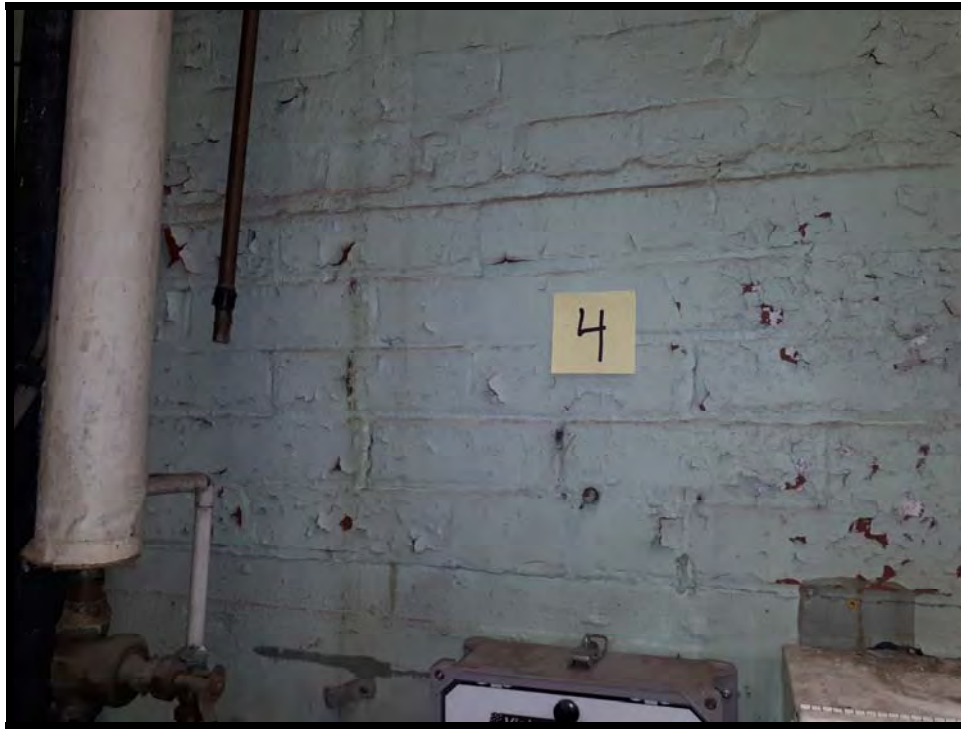
Photo # 44

*Sample # ONR – 4 : Wall paint located within the Power House - Room 100.
Deem to be Lead-based paint. (surface colour = green)*

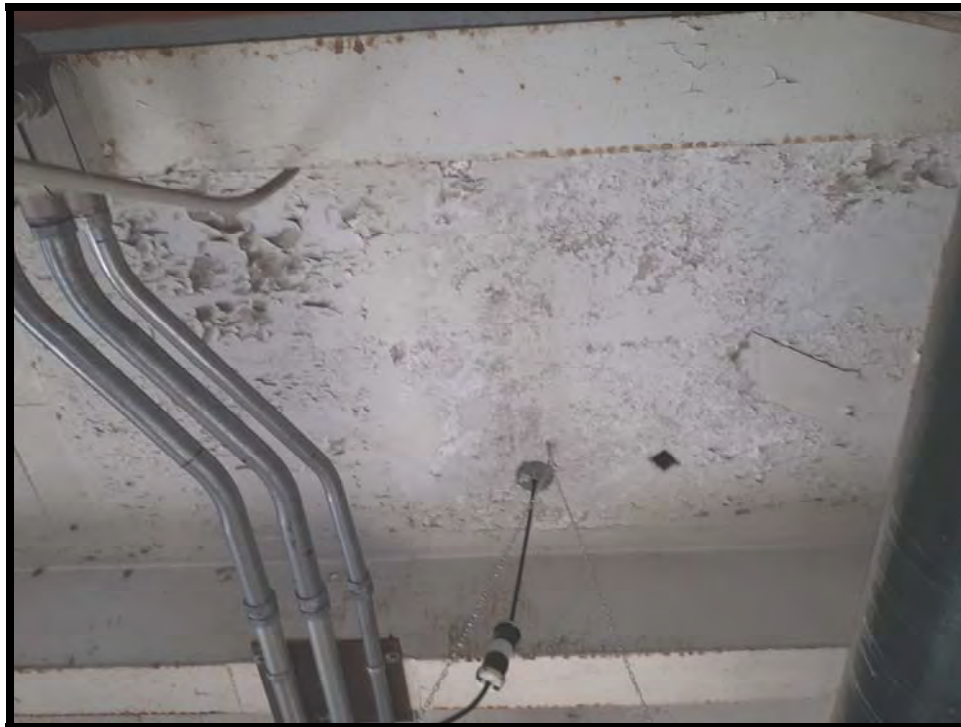
Photo # 45

*Sample # ONR – 5 : Ceiling paint located within the Power House – Room 100.
Deem to be Lead-containing paint. (surface colour = off white)*

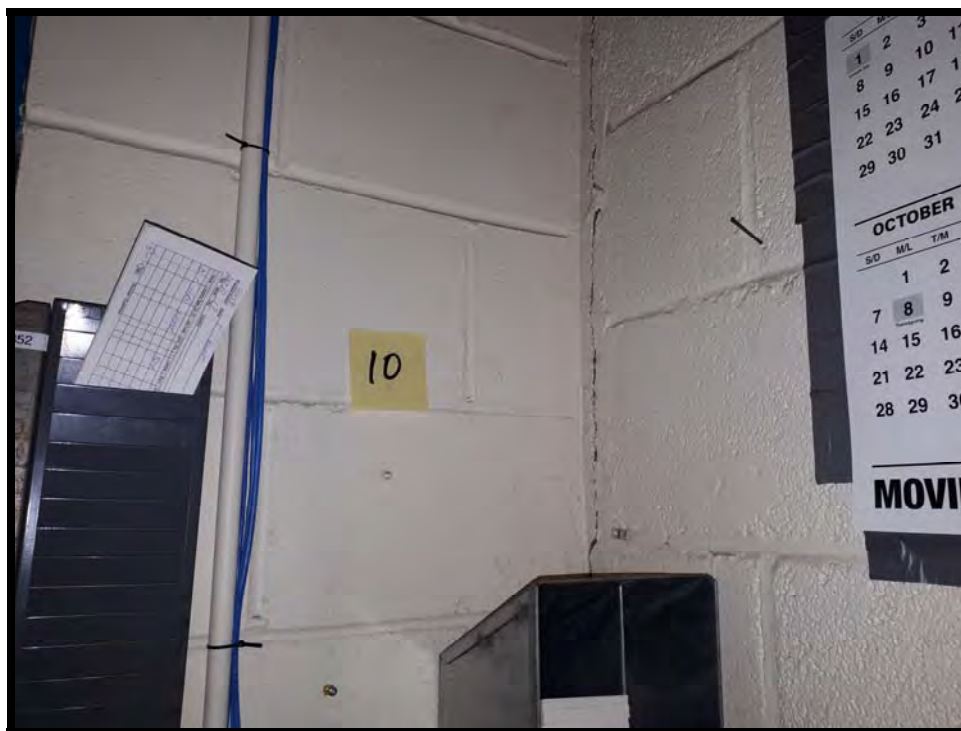
Photo # 46

Sample # ONR – 10 : Wall & Ceiling paint located within the Wheel Shop - Room 1.
Deem to be Lead-based paint. (surface colour = off white)

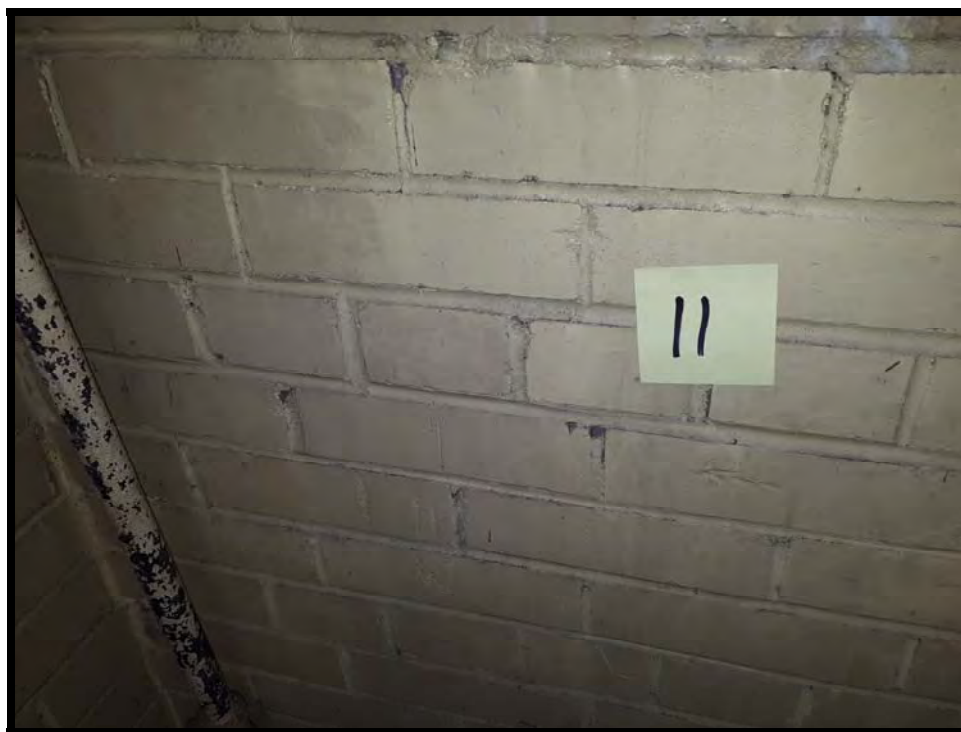
Photo # 47

Sample # ONR – 11 : Wall & Ceiling paint located within the Wheel Shop – Electrical Room.
Deem to be Lead-containing paint. (surface colour = yellow)

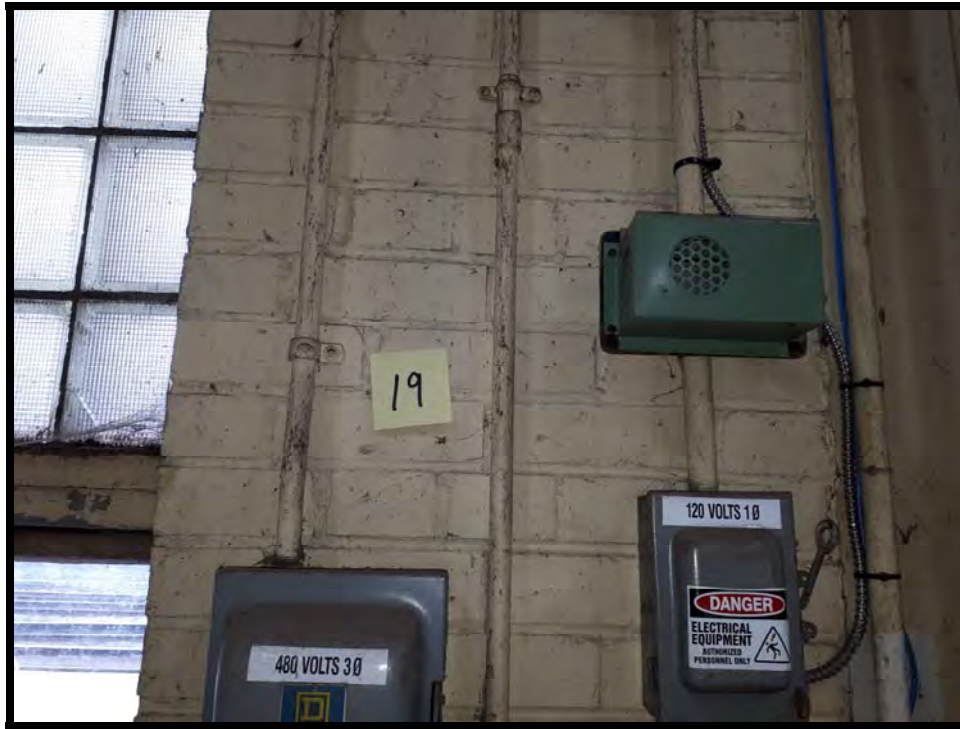
Photo # 48

*Sample # ONR – 19 : Wall paint located within the Wheel Shop - Room 7.
Deem to be Lead-based paint. (surface colour = beige)*

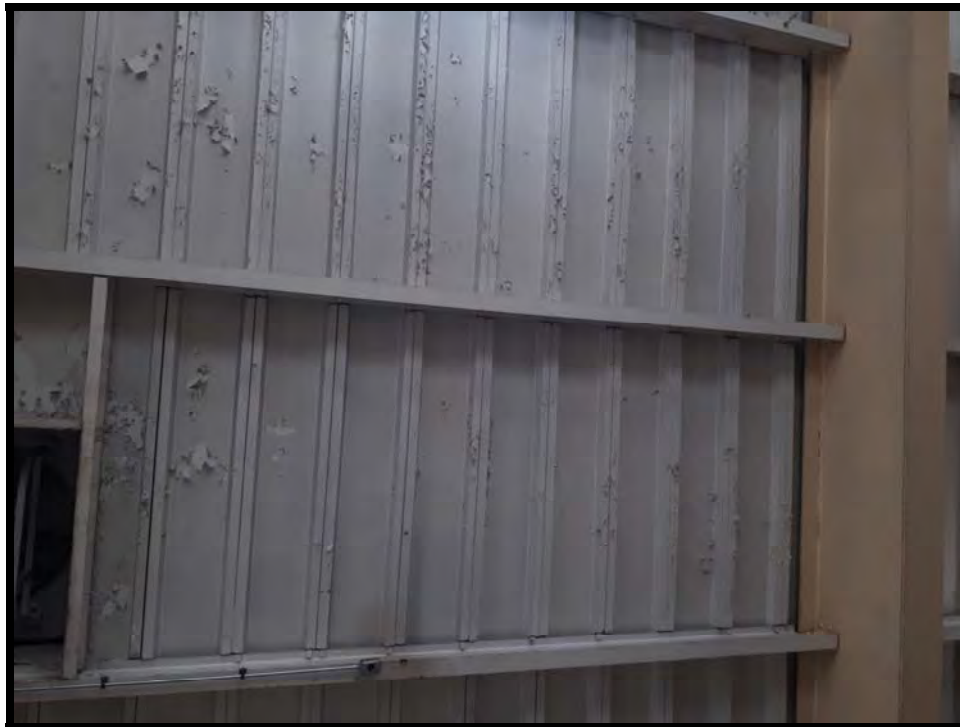
Photo # 49

*Sample # ONR – 21 : Ceiling paint located within the Wheel Shop – Room 7.
Deem to be Low-level lead paint. (surface colour = off white)*

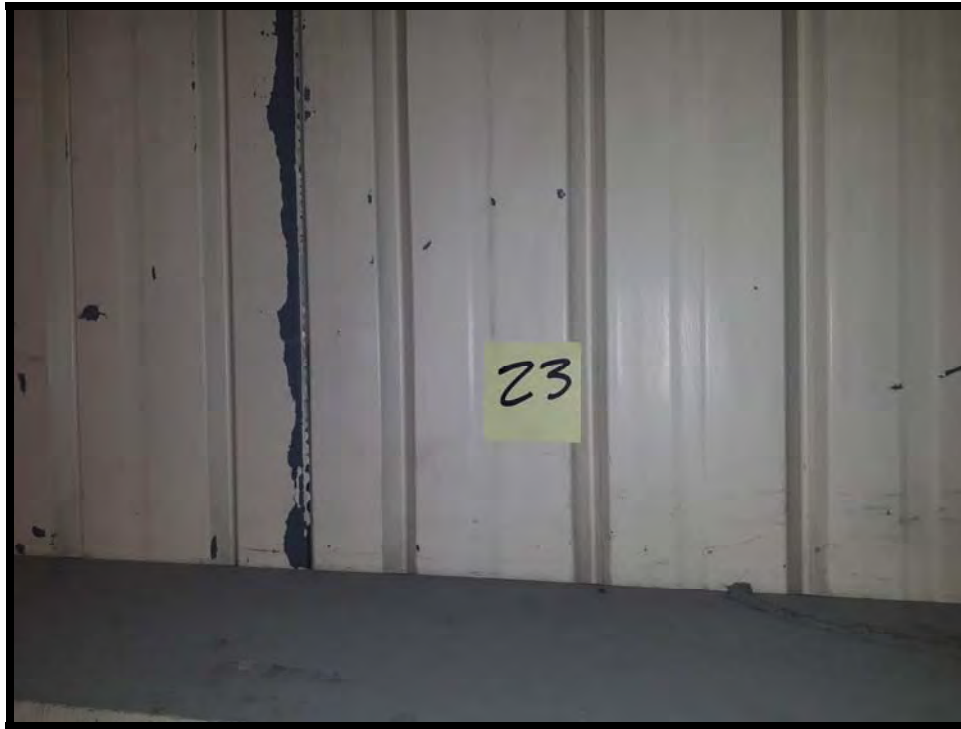
Photo # 50

Sample # ONR – 23 : Wall paint located within the “Old” Paint & Grit Shop – Stairs 1.
Deem to be Low-level lead paint. (surface colour = light beige)

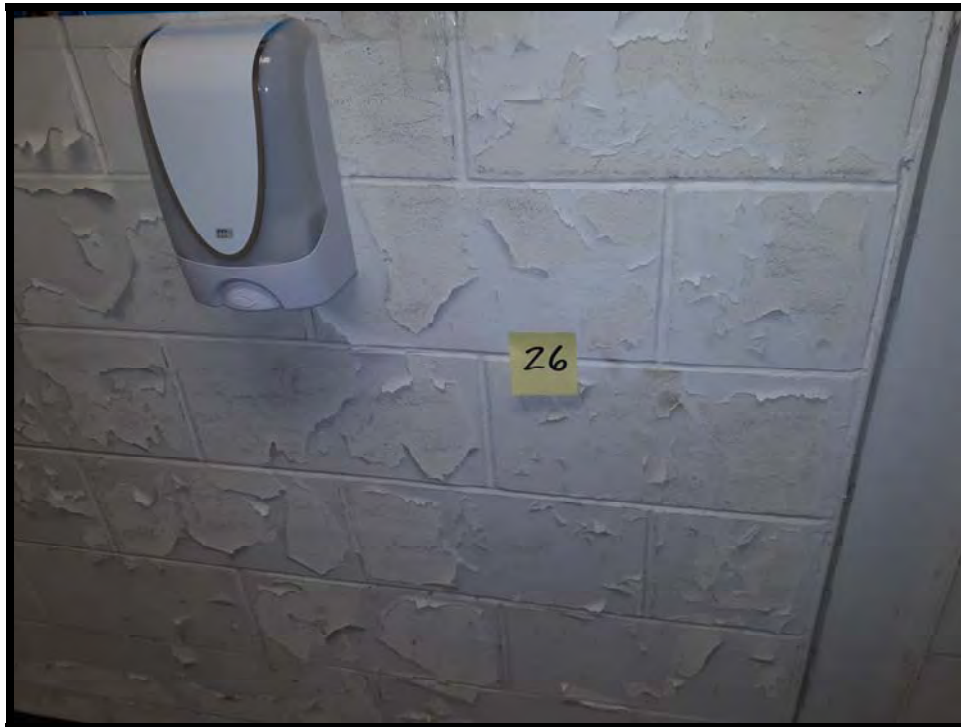
Photo # 51

Sample # ONR – 26 : Wall paint located within the “Old” Paint & Grit Shop – Room 9.
Deem to be Low-level lead paint. (surface colour = light beige)

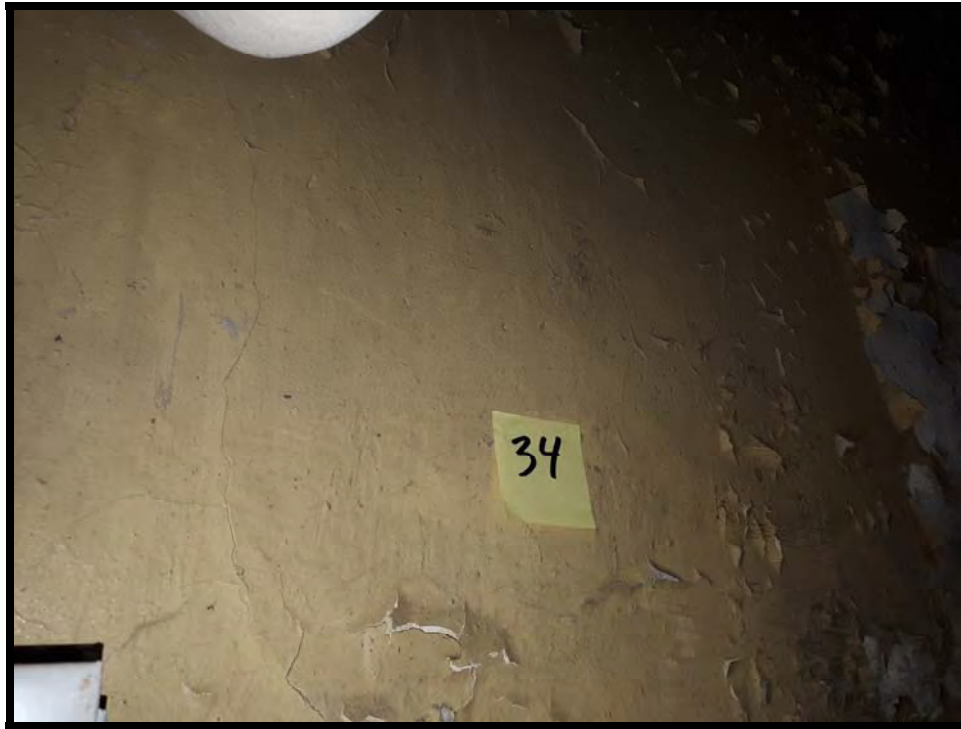
Photo # 52

*Sample # ONR – 34 : Wall & Ceiling paint located within the Diesel Shop – Room 3.
Deem to be Lead-containing paint. (surface colour = beige)*

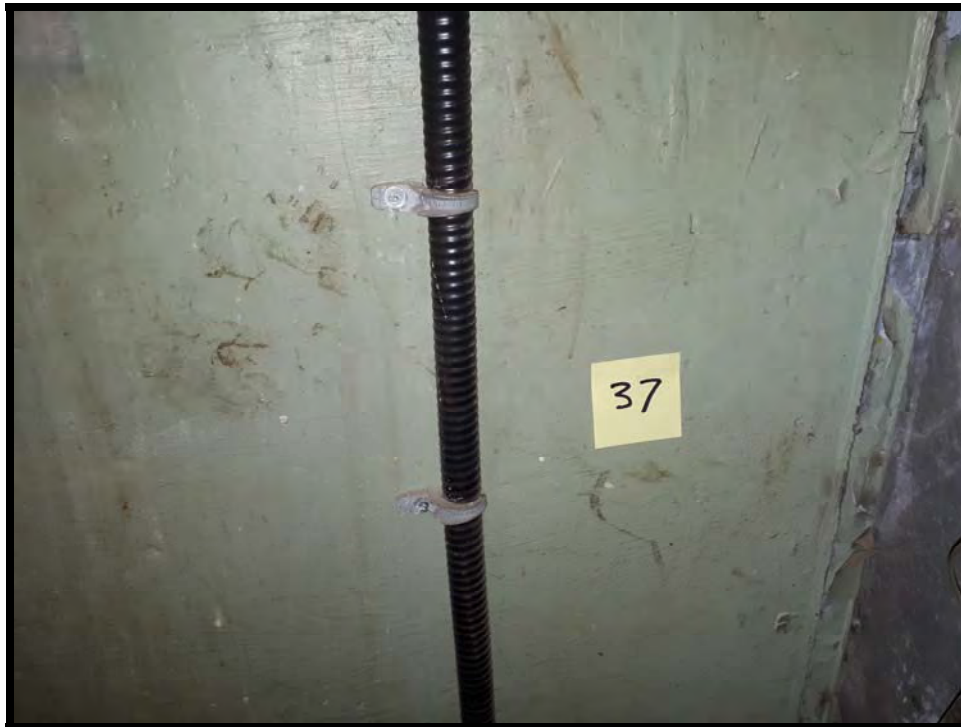
Photo # 53

*Sample # ONR – 37 : Wall paint located within the Diesel Shop – Room 6.
Deem to be Lead-based paint. (surface colour = green)*

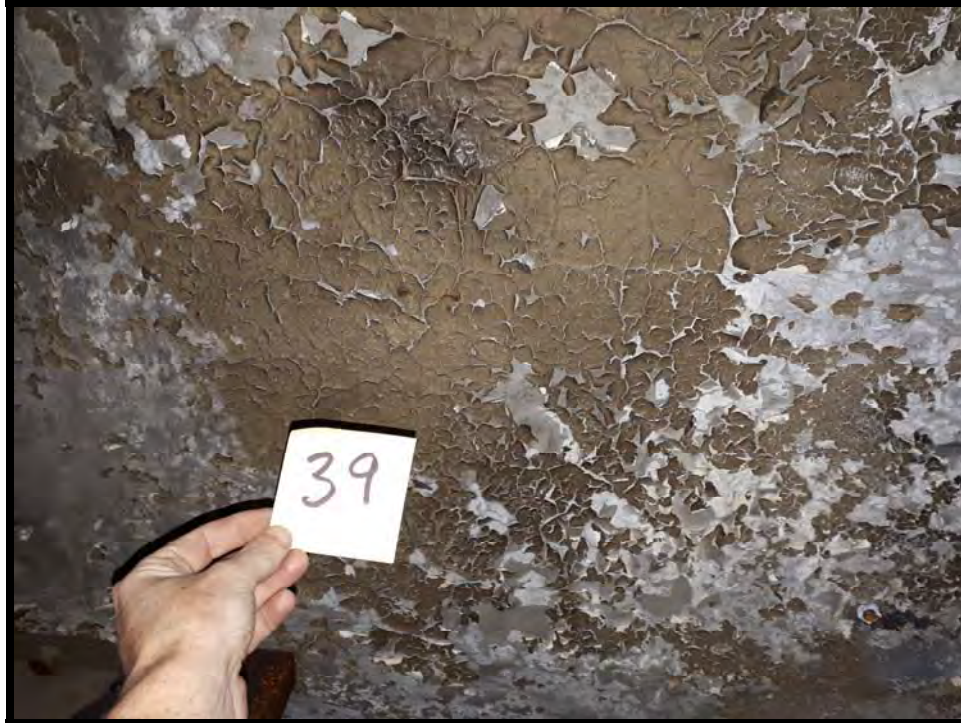
Photo # 54

*Sample # ONR – 39 : Ceiling paint located within the Diesel Shop – Room 5.
Deem to be Lead based paint. (surface colour = dark green)*

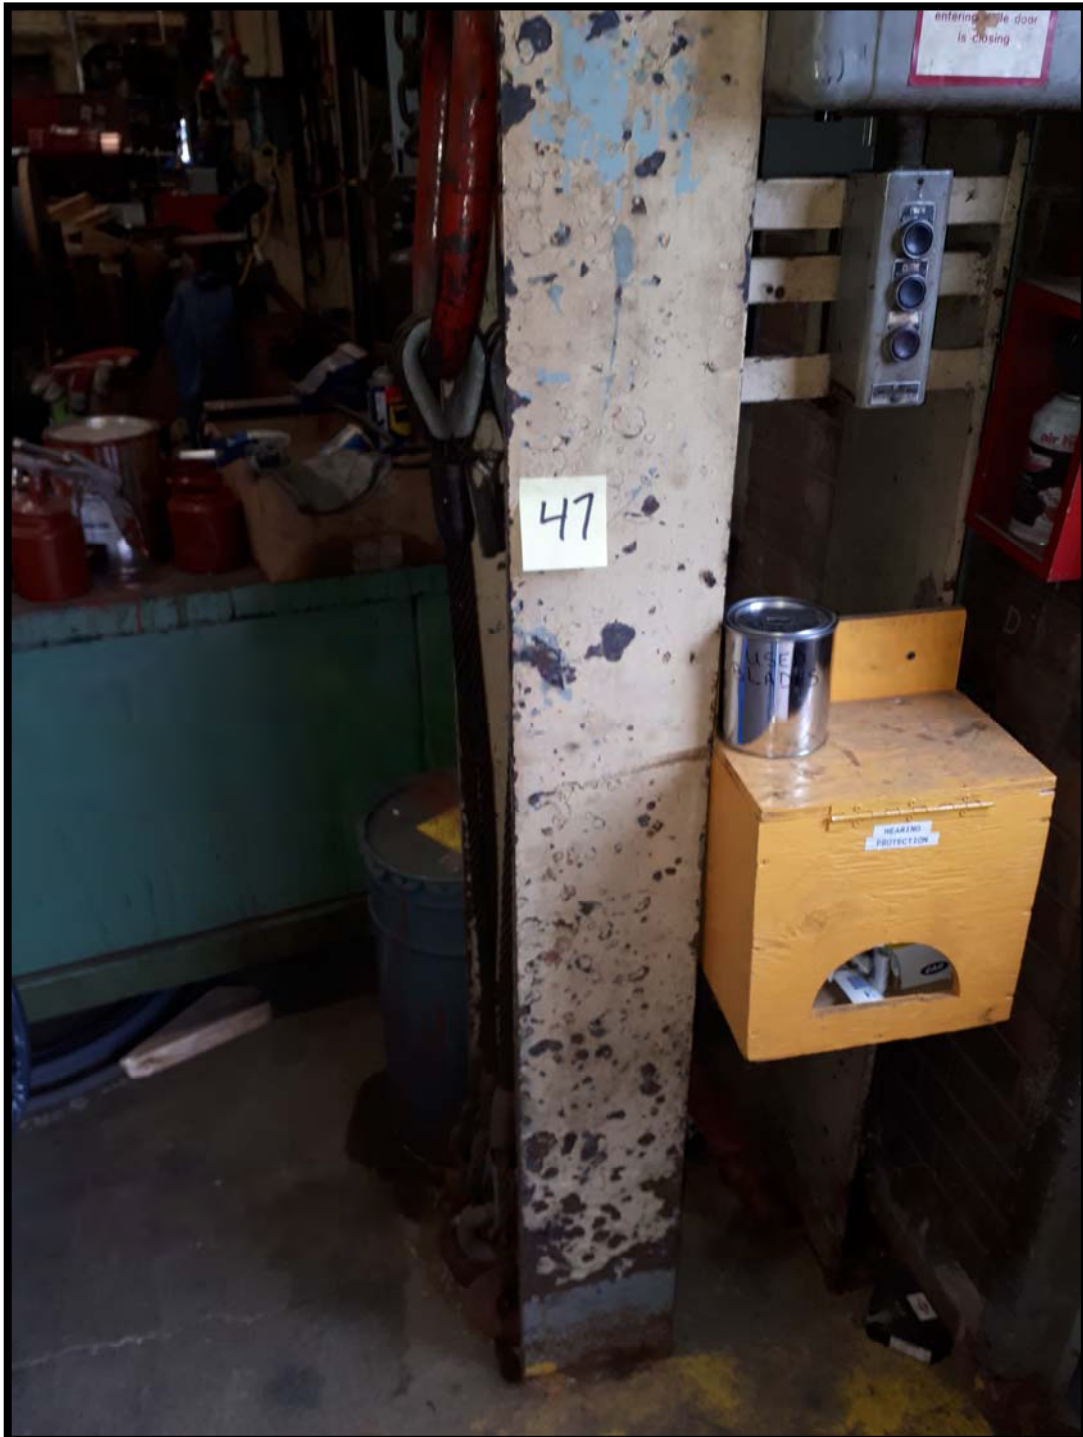
Photo # 55

*Sample # ONR – 47 : Structural Steel paint located within the Diesel Shop – East Area.
Deem to be Lead-based paint. (surface colour = beige)*

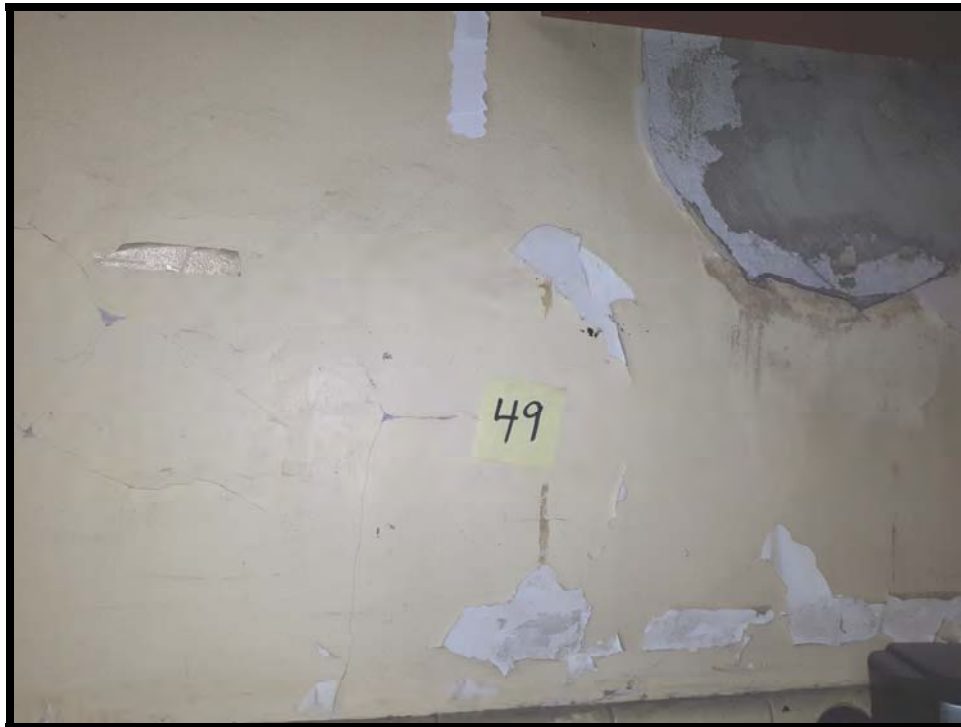
Photo # 56

*Sample # ONR – 49 : Wall & Ceiling paint located within the Diesel Shop – Room 16.
Deem to be Lead-containing paint. (surface colour = light beige)*

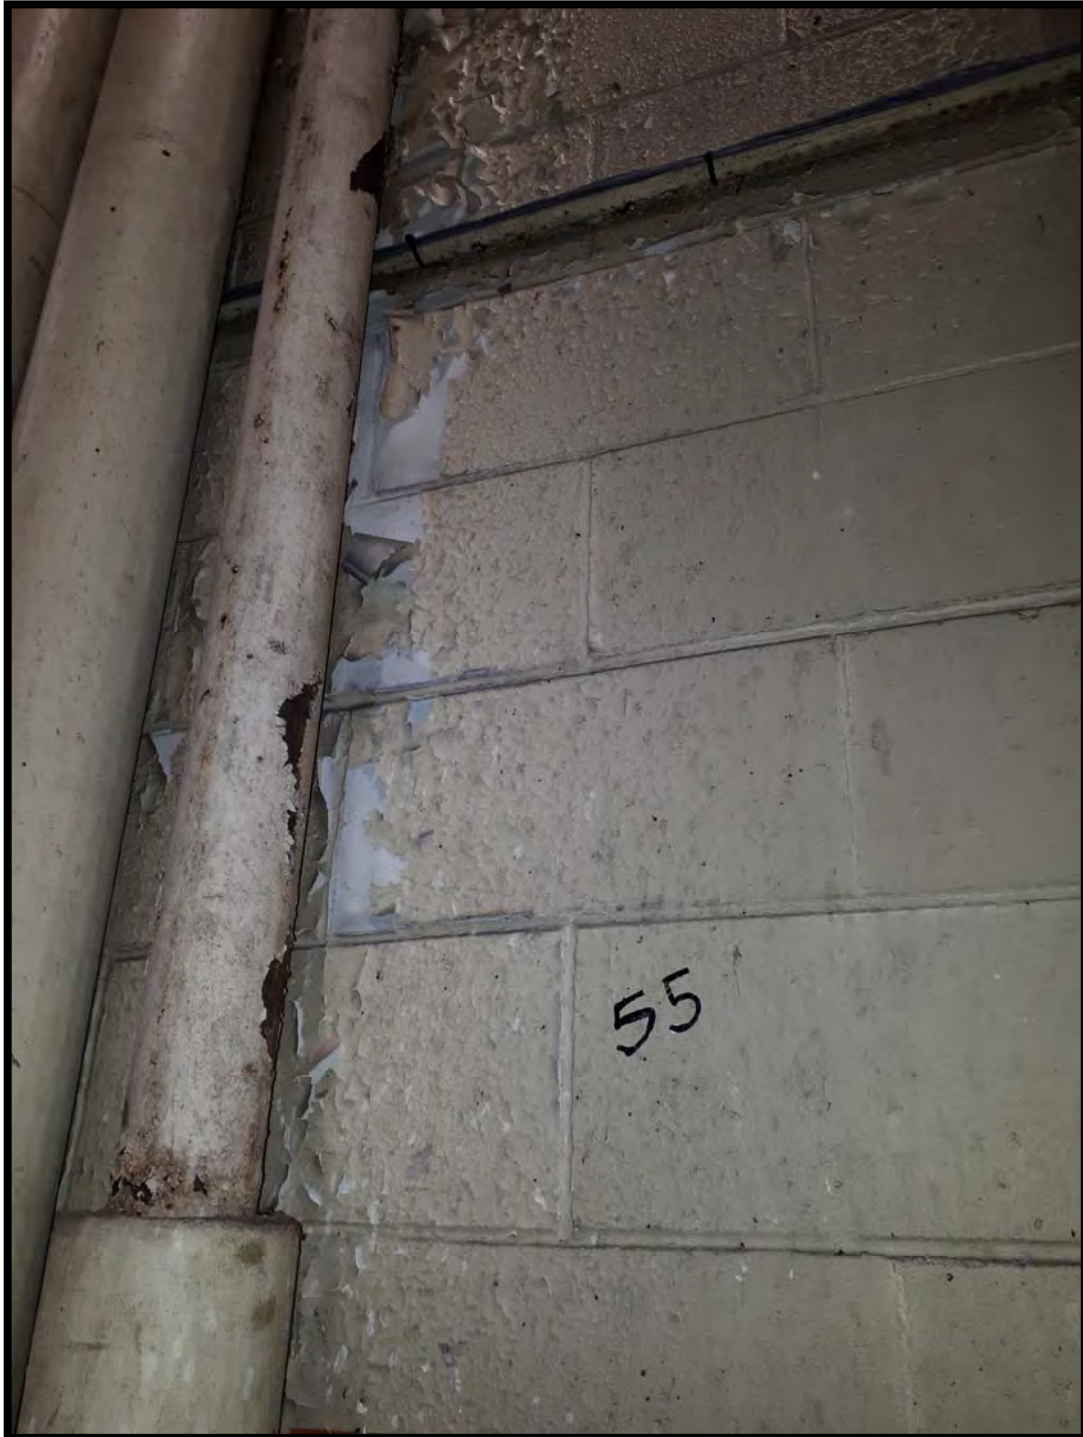
Photo # 57

*Sample # ONR – 55 : Wall paint located within the Diesel Shop – Addition Area.
Deem to be Low-level lead paint. (surface colour = green)*

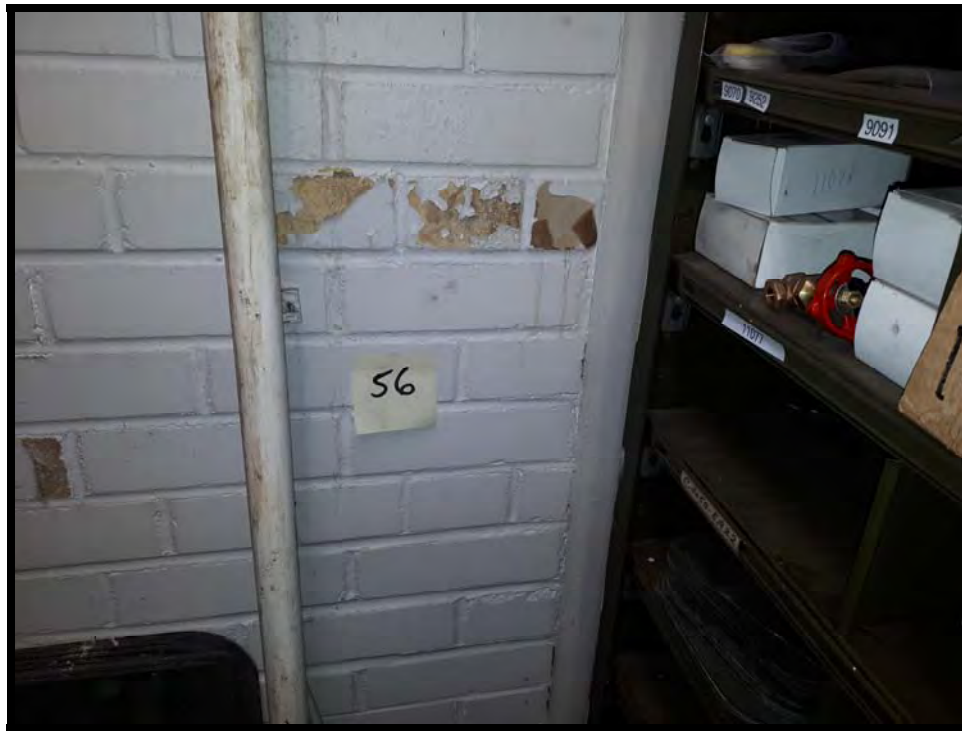
Photo # 58

Sample # ONR – 56 : Wall & Ceiling paint located within the Diesel Shop – Room 100.
Deem to be Lead-containing paint. (surface colour = light beige)

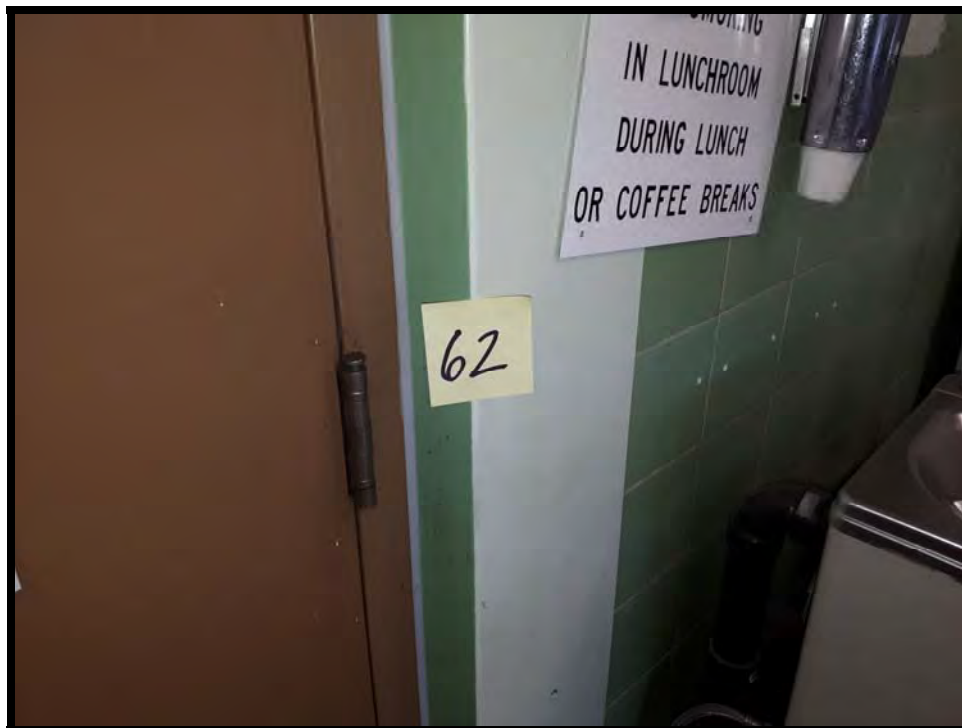
Photo # 59

Sample # ONR – 62 : Wall paint located within the Diesel Shop – Room 201.
Deem to be Lead-based paint. (surface colour = green)

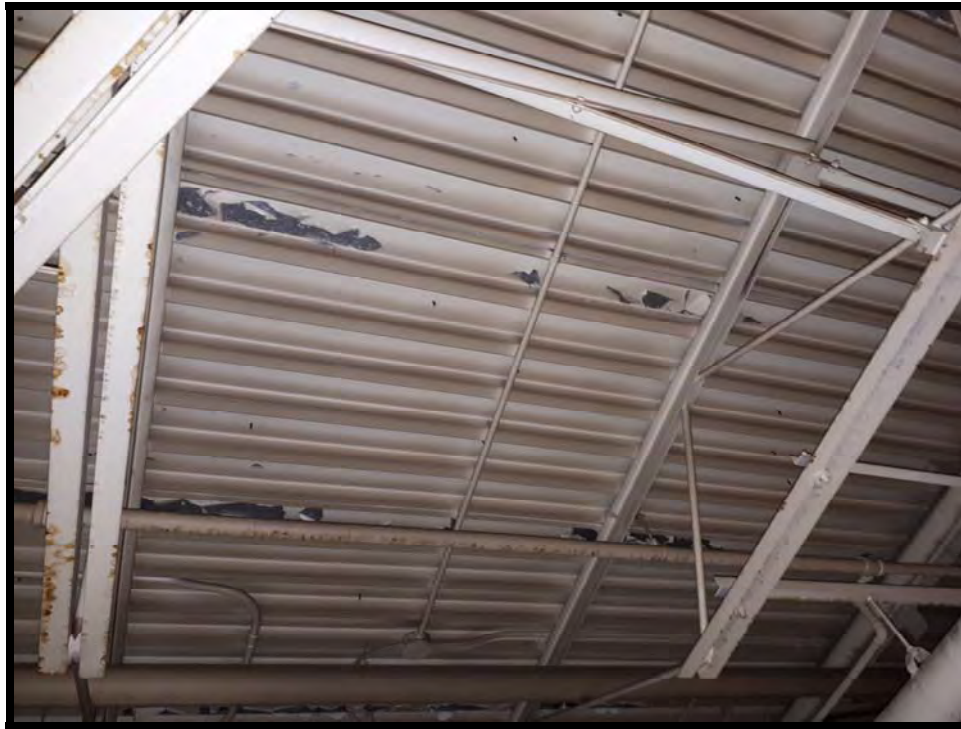
Photo # 60

Sample # ONR – 66 : Ceiling paint located within the Car Shop – Room 200.
Deem to be Lead-based paint. (surface colour = beige)

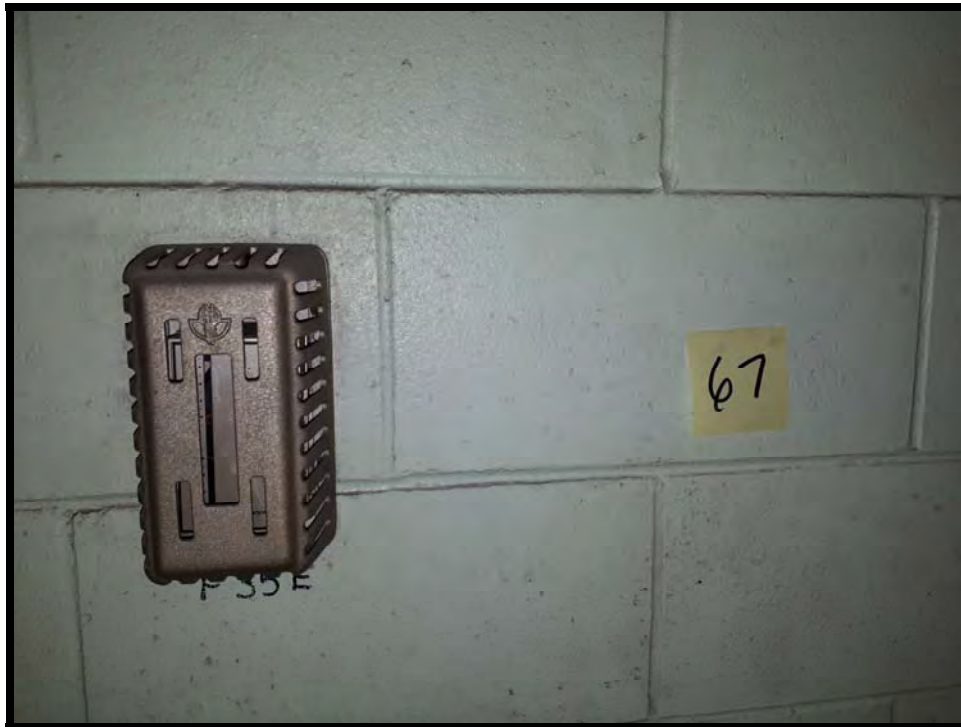
Photo # 61

Sample # ONR – 67 : Wall paint located within the Car Shop – Room 200.
Deem to be Lead-based paint. (surface colour = green)

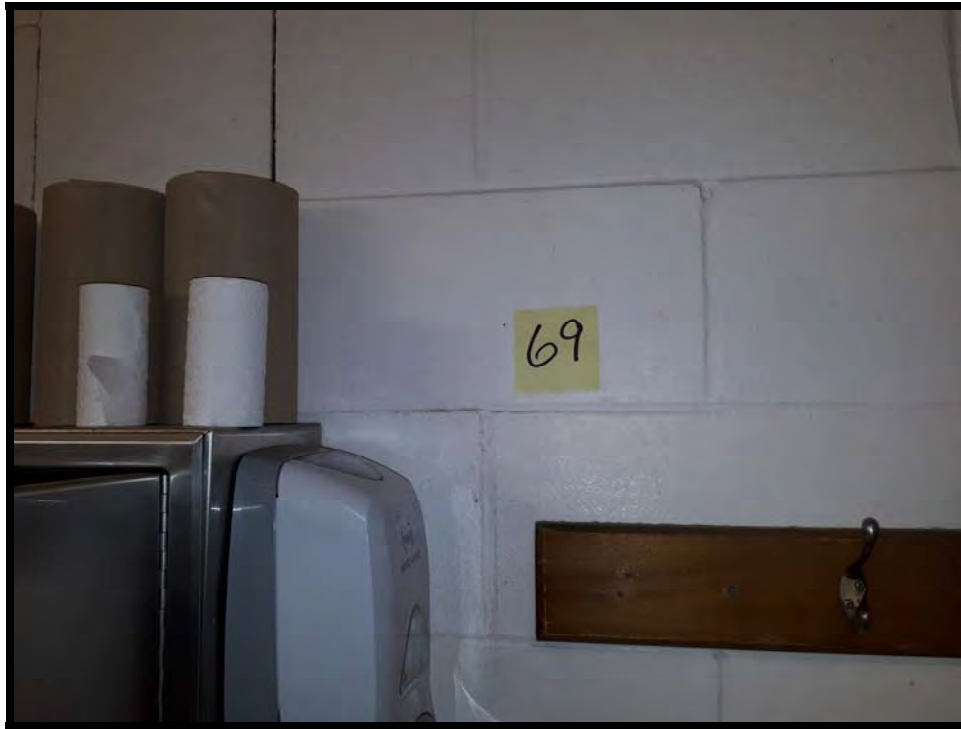
Photo # 62

*Sample # ONR – 69 : Wall paint located within the Car Shop – Room B.
Deem to be Low-level lead paint. (surface colour = light beige)*

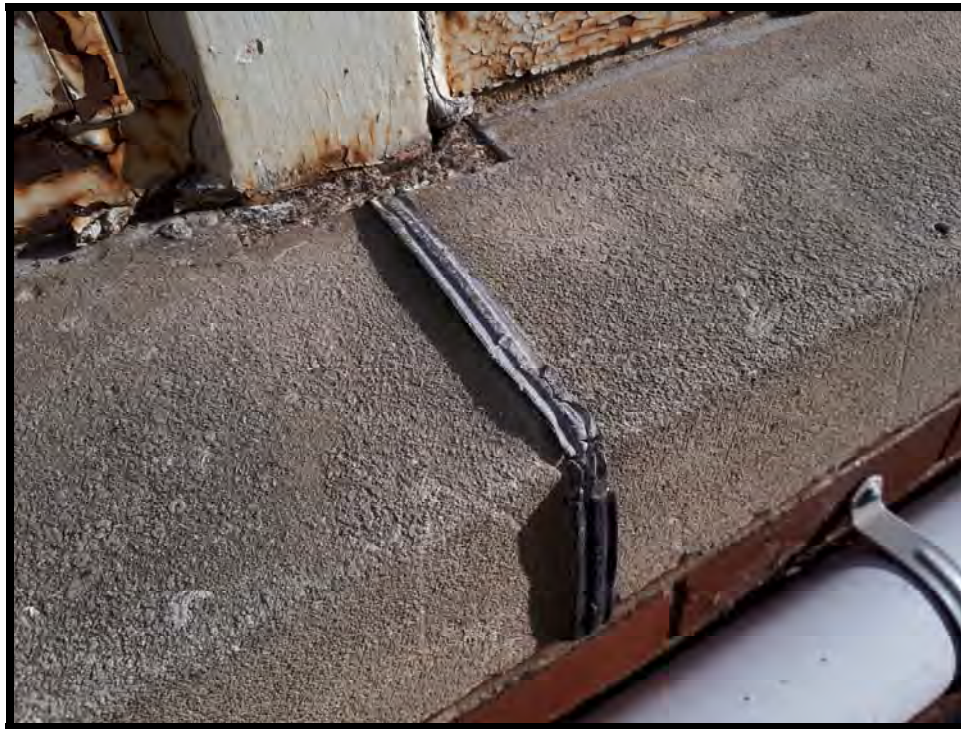
Photo # 64

<p>Diesel Shop (Original Area)</p>	<ul style="list-style-type: none"> • Wall, ceiling and structural paint observed within the building is classed as both <u>Lead-containing and Lead-based paint</u>. • Exterior window / door flashing and window sill plate caulking (see photos 63 & 64 in Appendix B) are both classed as <u>Lead-based materials</u>.
<p>Diesel Shop (Addition Area)</p>	<ul style="list-style-type: none"> • Wall, ceiling and structural paint observed within the building is classed as <u>Low-level lead paint</u>. • Exterior window / door flashing and window sill plate caulking (see photos 63 & 64 in Appendix B) are both classed as <u>Lead-based materials</u>.
<p>Car Shop</p>	<ul style="list-style-type: none"> • Wall, ceiling and structural paint observed within the building is classed as <u>Low-level lead paint</u>. • Lead-acid batteries storage in Room 117 (see photo 64a in Appendix B).

*Lead-based caulking used on exterior windows sill's on Wheel Shop.
Also used on exterior windows and doors on Wheel Shop.*

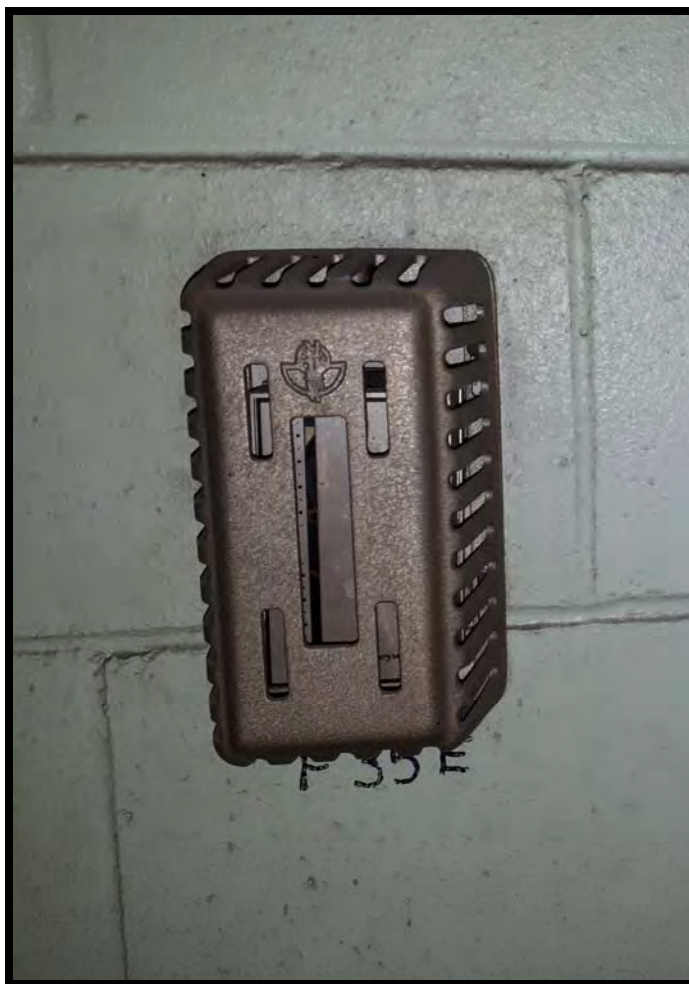
Photo # 67

*Wall mounted "Honeywell" Thermostatic Control Switch – Mercury Containing.
Located within the Car Shop – Room 200.
Typical of other Thermostats' found throughout all buildings.*
